**HOPEWELL RAILROAD STATION
HOPEWELL, NEW JERSEY**

PRESERVATION PLAN

January 1996

Ford Farewell Mills and Gatsch, Architects
864 Mapleton Road
Princeton, New Jersey 08540
609-452-1777 fax 609-452-7192

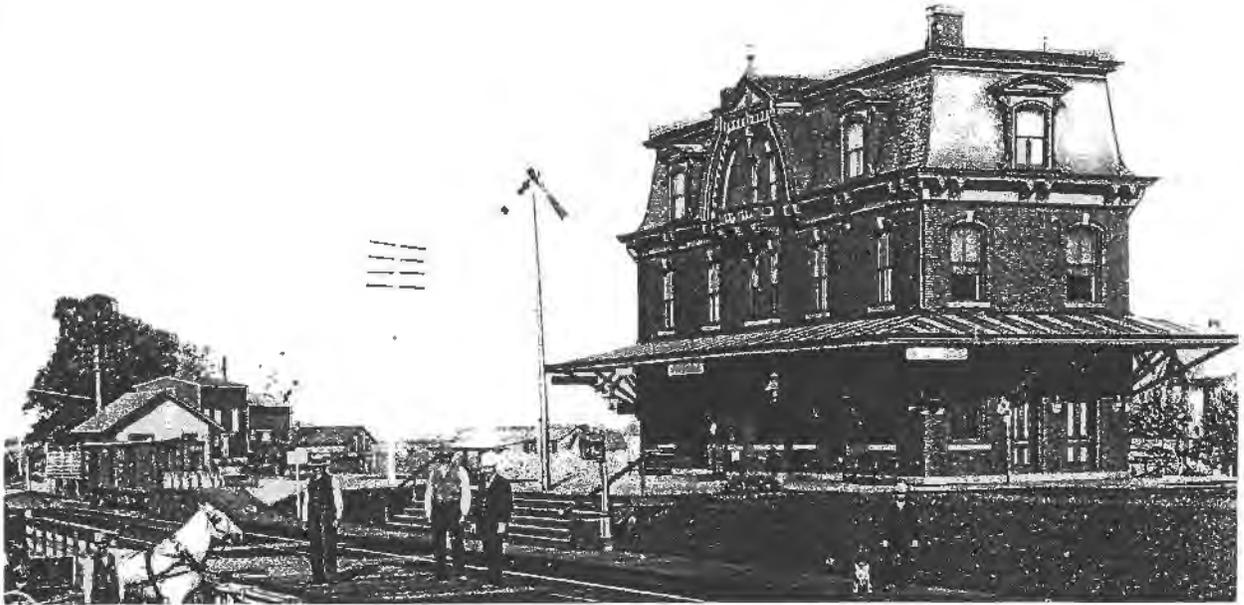
Figure 2: Photograph of the station from the northwest around the turn of the century.

The Railroad Station site has been well documented in post card views and in photographs from various historic periods. One of the most well known was published in 1990 in Hopewell: A Historical Geography, by Richard Hunter and Richard Porter. Prominent in that photograph are the original wooden platforms; which were replaced with concrete probably by the second quarter of this century. (Figure 2)

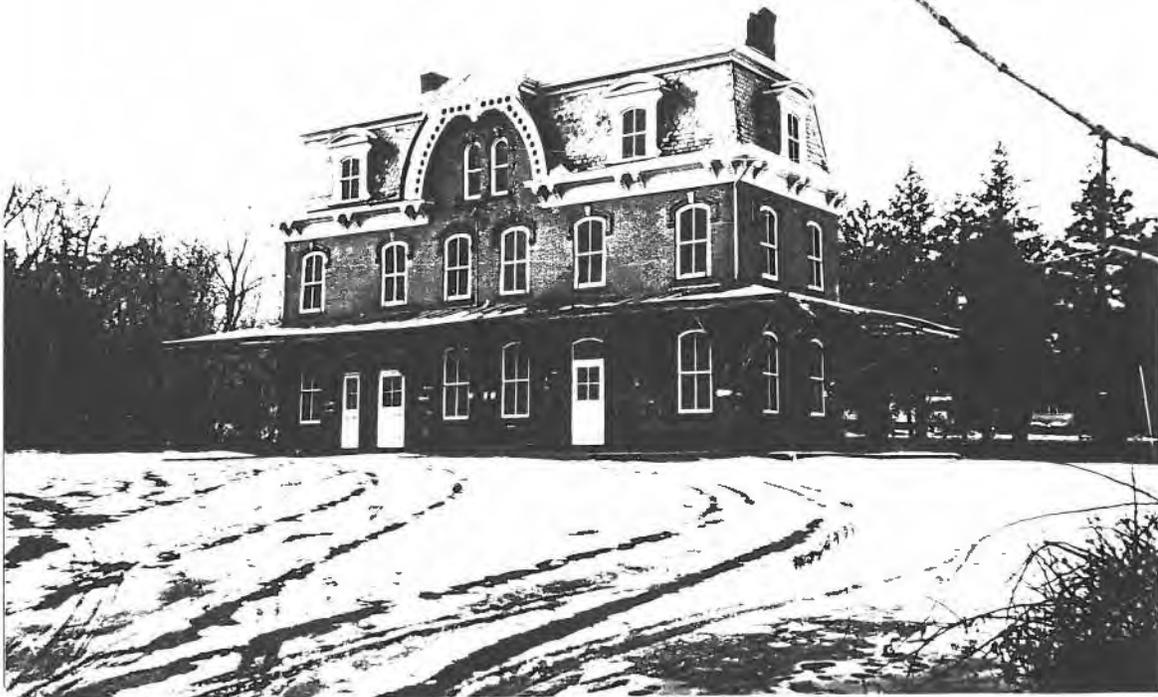
Photo 3: Station from southeast.
Cornice and dormer trim have been partially restored.
Openings have been secured with plywood painted to simulate doors and windows

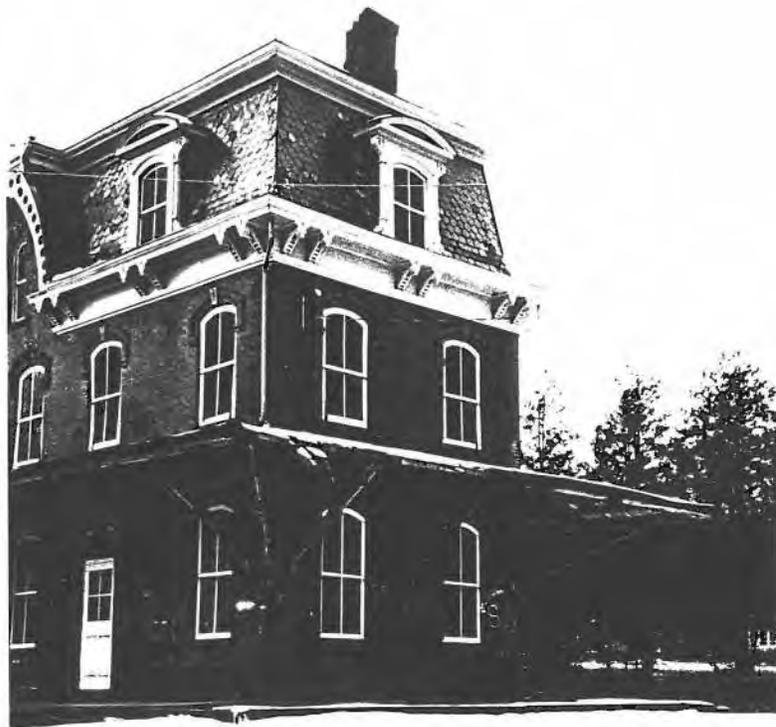
The pent roof is a character-defining feature of the station that will require a great deal of restoration work. The roof structure on the south side has pulled away from the masonry approximately three inches. The decorative wood brackets appear to be sound. They show some deformation related to the movement of the roof, and need to be returned to their original geometry. The metal roof is heavily deteriorated and unsalvageable. The wood structure, sheathing, and decorative work has sustained a considerable amount of water damage. (See Photo 5)

Photo 5: Station from southeast.
Note severe deterioration of canopy at southeast corner.

Because of the extent of deterioration, it is anticipated that the roof and roof structure will have to be entirely removed. All decorative brackets should be carefully salvaged for reuse. It is recommended that as many structural members as possible be reused for the new roof structure.

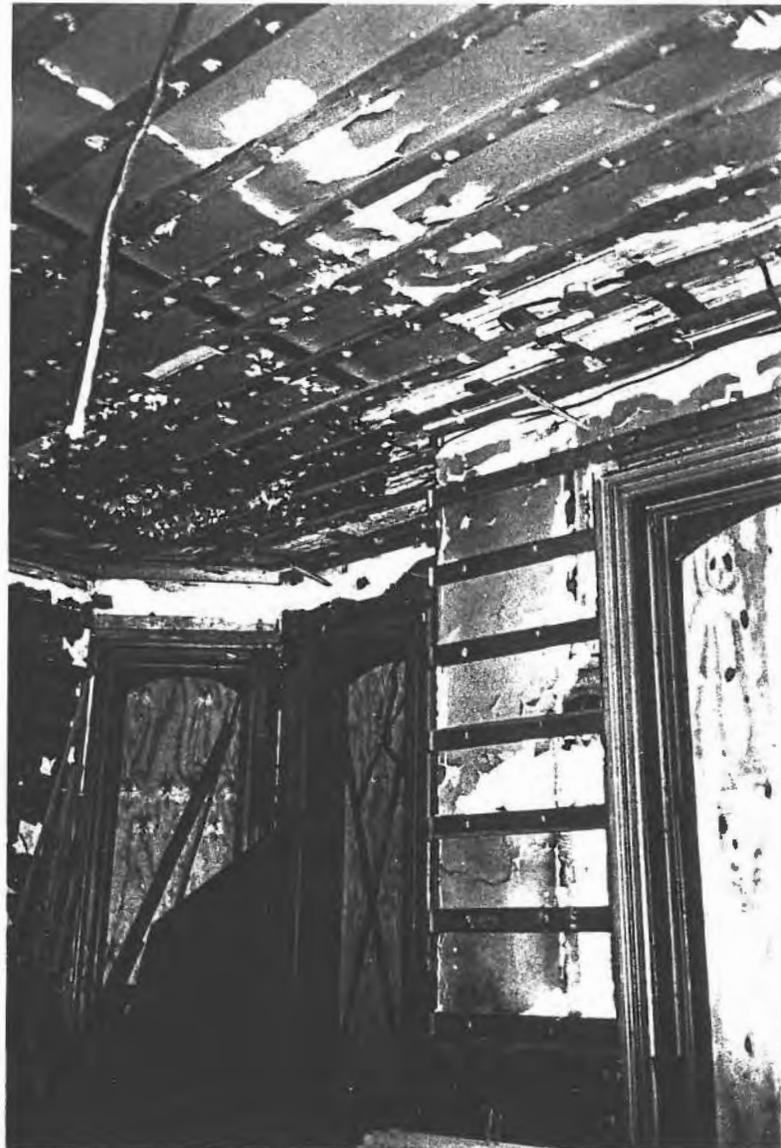
Wood furring strips were installed over the original plaster which has damaged it in many locations. (See Photo 9) With the removal of the furring, more damage can be expected. Any loose or damaged plaster should be removed and patched in kind. A new skim coat of plaster may be required to blend the existing and new work. The transition between the walls and ceiling has been stripped off to create a flush surface. If the original plaster cornice exists at the companion, Pennington station, it should be replicated at the Hopewell Station. If none exists there, an appropriate architectural precedent should be found at another Station of the same period, such as Fanwood; or taken from a Victorian pattern book of the period.

Photo 9: Mens' waiting room, looking into bay window in stationmaster's office. Later wall and ceiling coverings have been removed, showing added furring strips over original plaster. Ghost of former partition is visible at left of window to right.

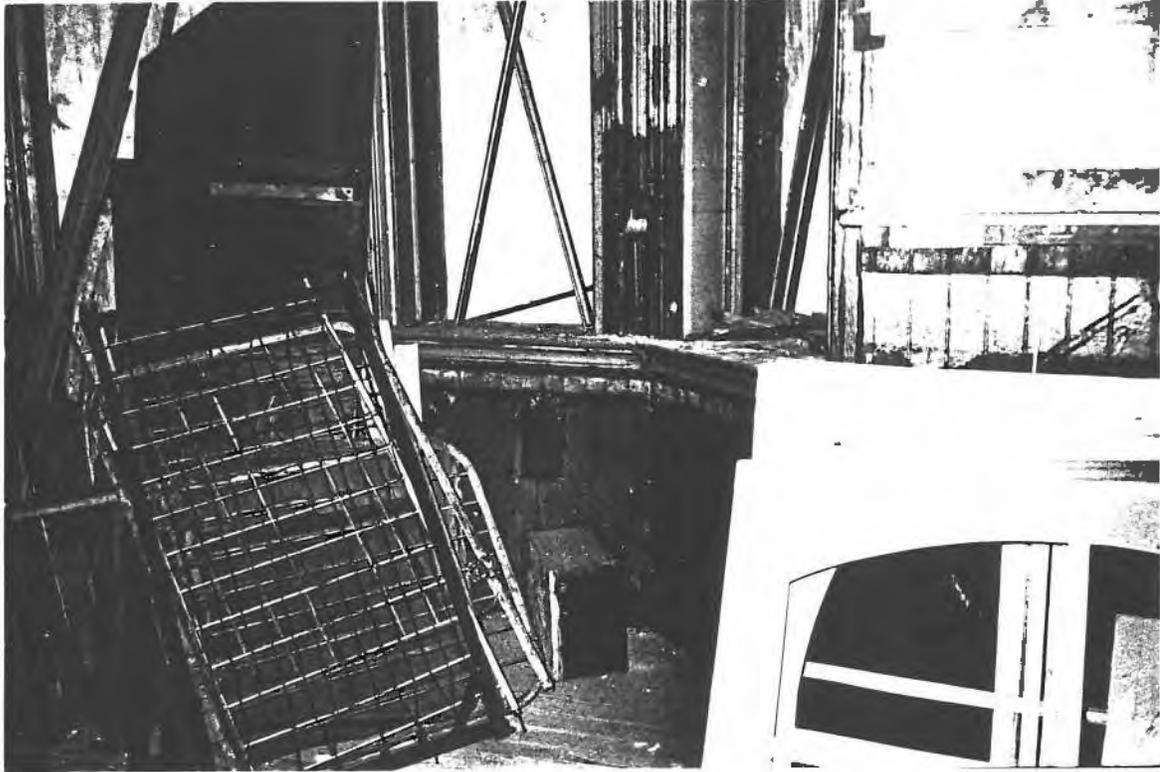
The match board wainscot and baseboards are in good condition with only minor carpentry repairs needed. The original chair rail was removed to allow the installation of a modern wall finish (probably veneer paneling, which was removed to prepare the interior for restoration); and the chair rail should be restored to match surviving fabric elsewhere.

Photo 10: Stationmaster's office. Ghost of chair rail is visible above matchboard wainscot.

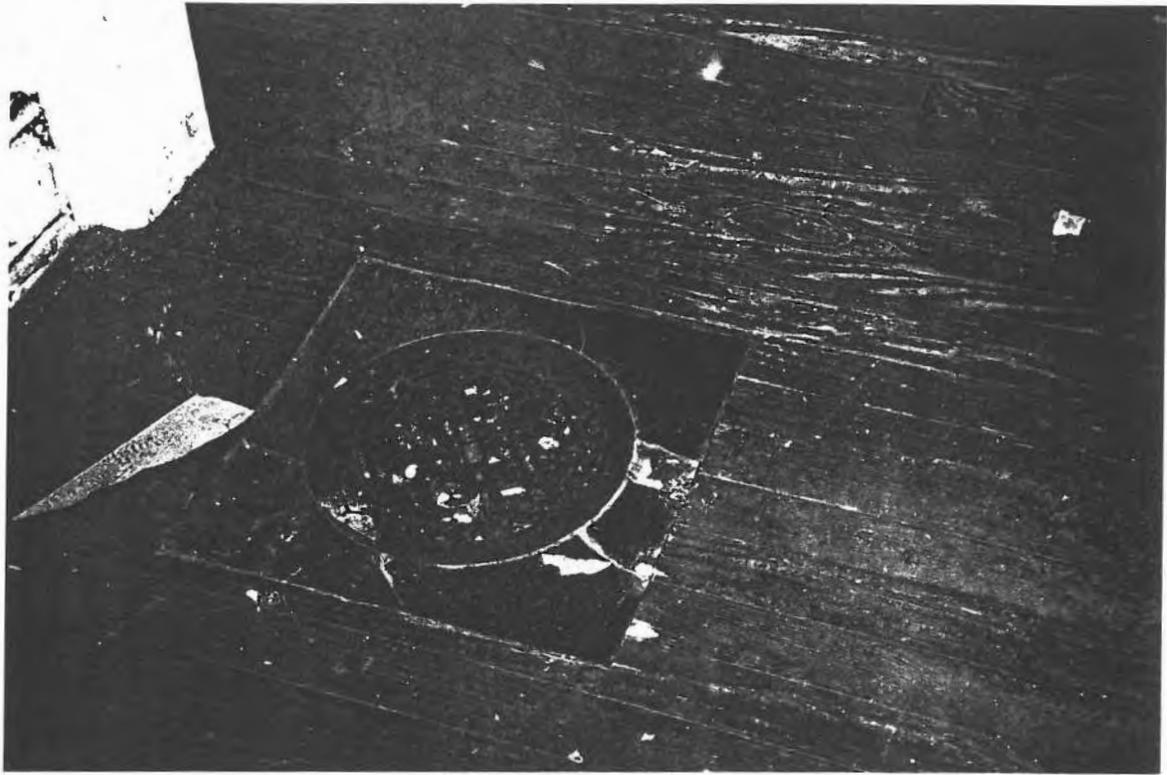
The finished floor consists of straight grain, southern yellow pine, known locally as "comb grain" pine. It is a very durable surface because the floorboards contain a large amount of heart wood. Areas of heavy wear exist, but it is felt that the majority of the floor is salvageable; therefore, it should be sanded and refinished. The existence of diagonal board subfloor will facilitate any repairs that are needed. Some early, cast iron floor registers survive in various locations and these should remain even if not utilized in the mechanical design. (See Photo 11)

Photo 11: Typical floor register.

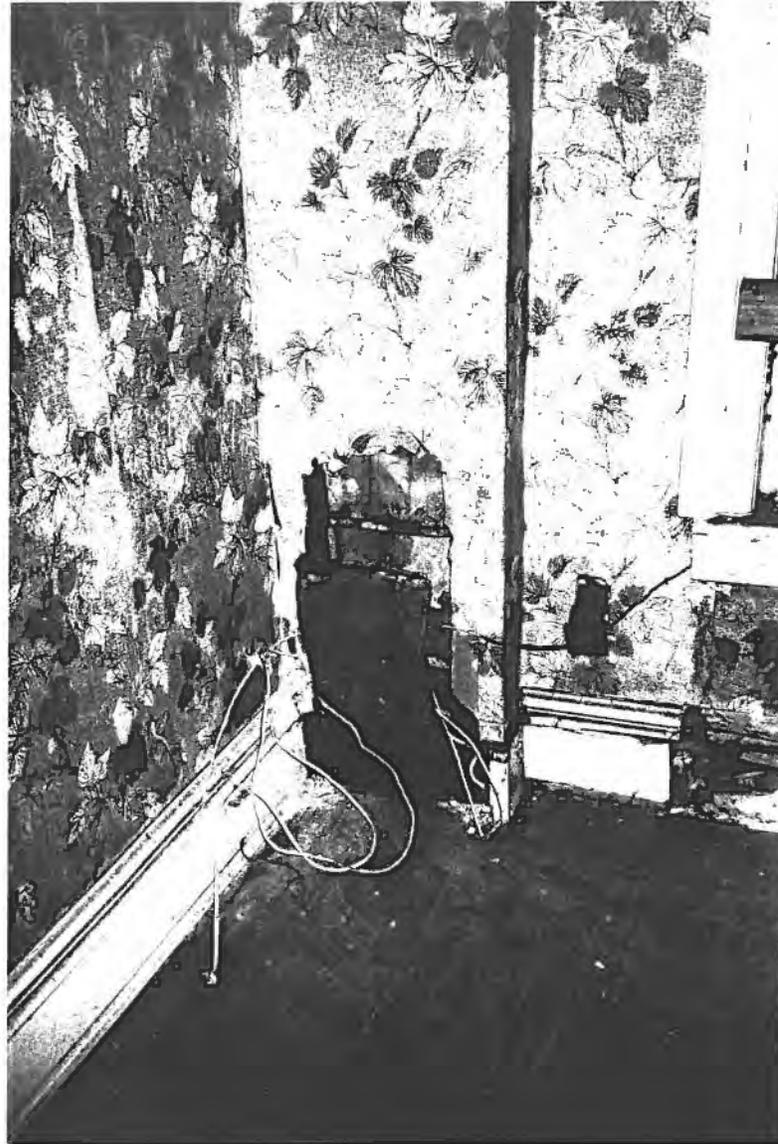
Photo 12: Added duct in Room 202. Note condition of wiring.

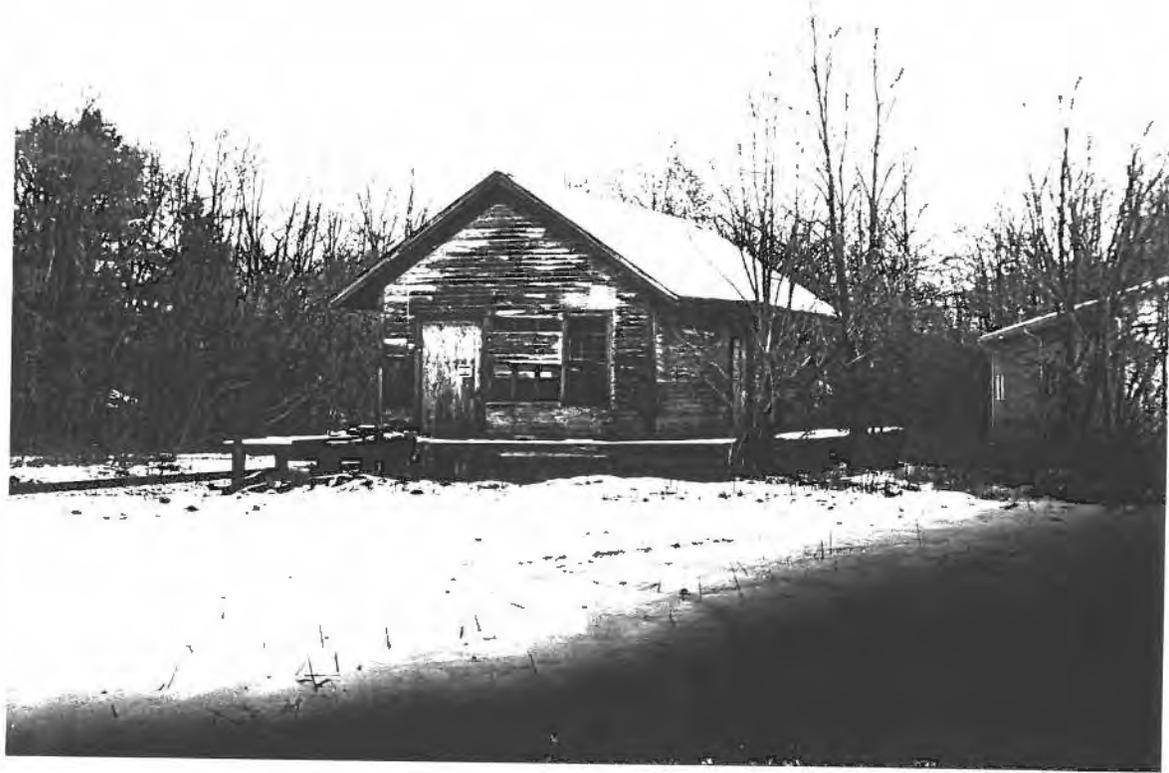
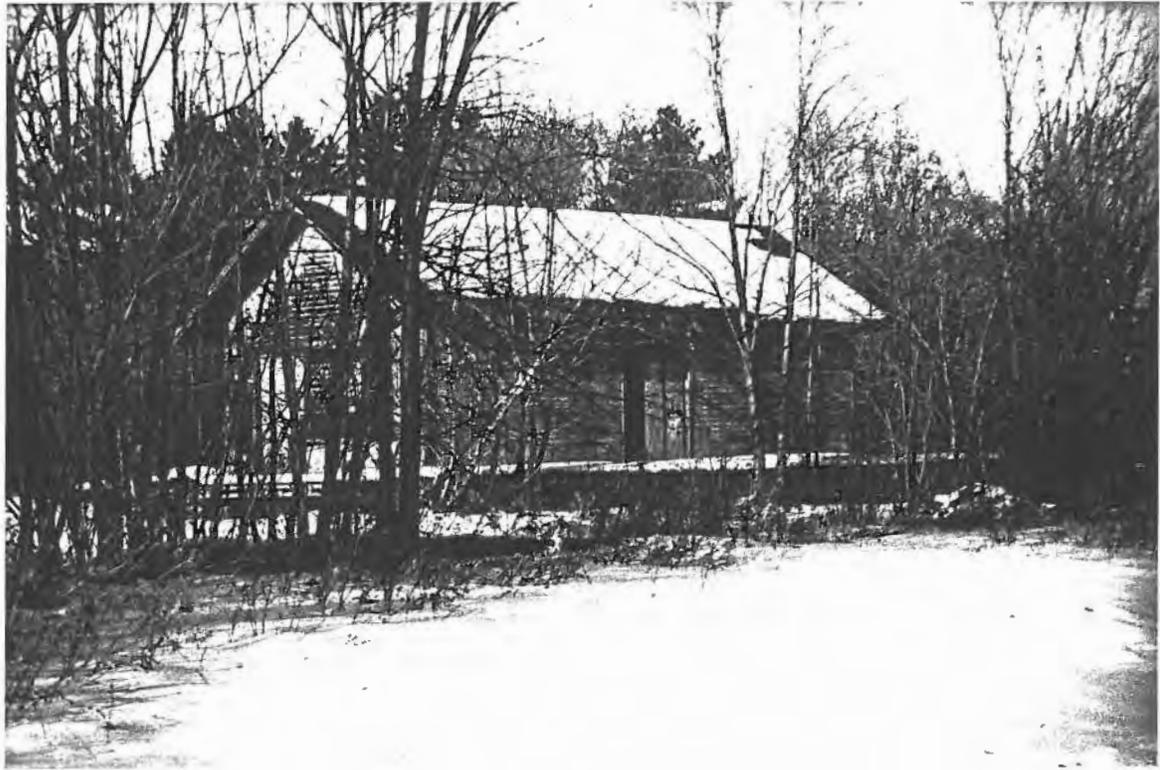
The clapboard freight building is an intrinsic part of the railroad station setting, and is on the National Register of Historic Places. (Photos 19 and 20) Although the platforms of the freight building have suffered due to poor maintenance and vandalism; the building, which sits on its own stone foundation, is in surprisingly good structural condition. Only one area of structural damage

was noted in a recent site inspection, and this can be easily repaired with traditional carpentry techniques. Some areas of clapboard and the windows and doors have been damaged beyond repair by vandals.

Photo 19: Freight station from southwest.

Photo 20: Freight station from northeast.

To preserve the structural and architectural integrity of the freight building, and to keep it on an equal basis with the railroad station improvements, it is recommended that the exterior envelope of the freight building be restored as a part of this project. This will involve a new roof covering, clapboard restoration, carpentry repairs, new doors and windows to match historic conditions, and painting of the exterior with a historically appropriate color scheme. A smoke detection system should be provided to protect the building.

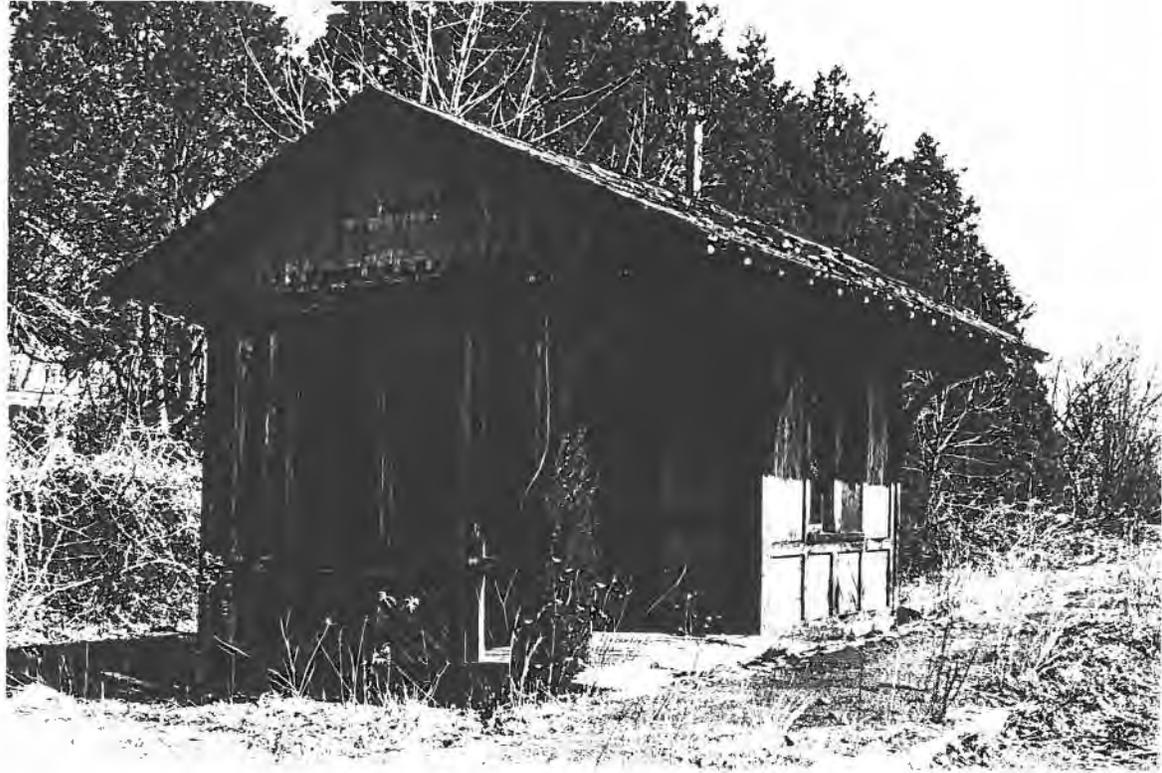
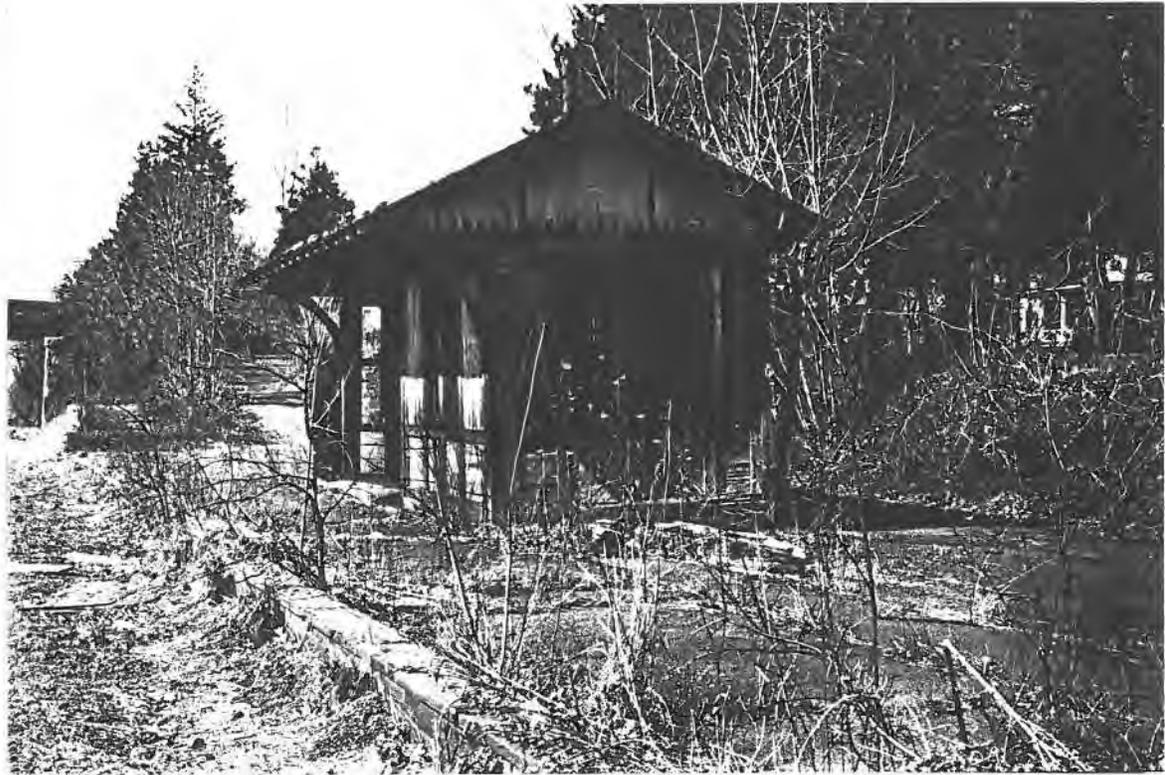
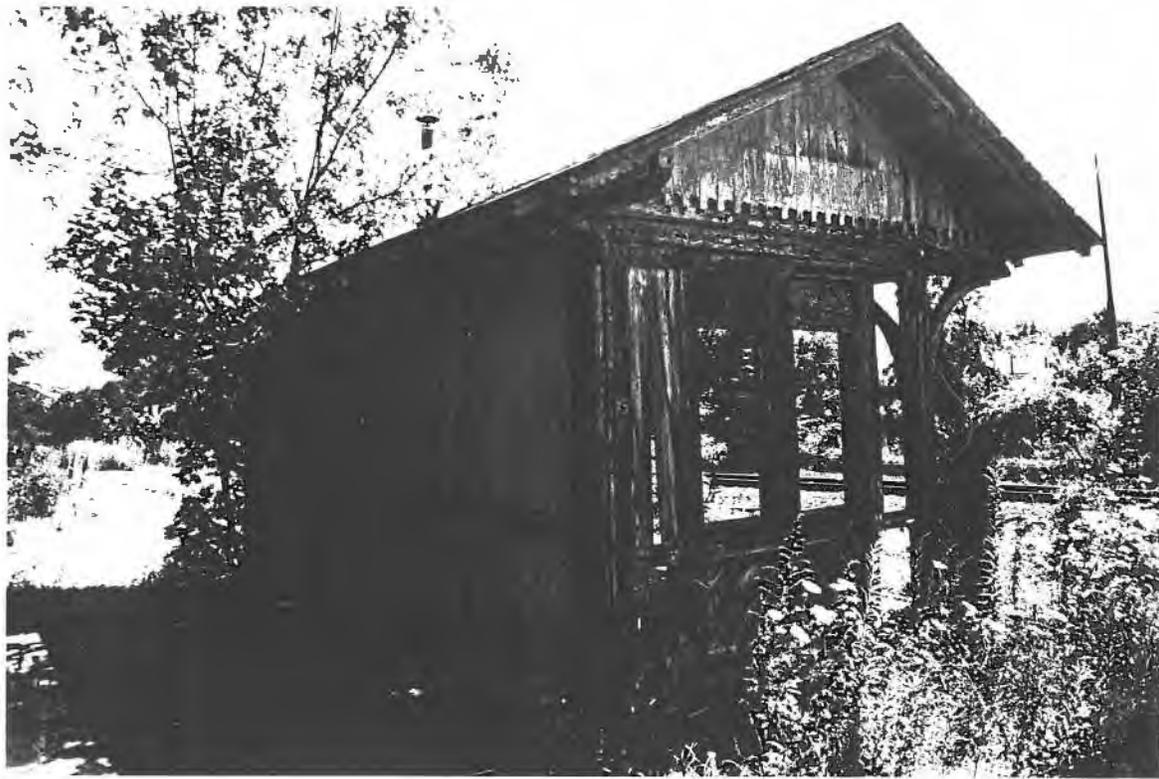
In recent years, the Shelter on the north side of the tracks was destroyed by arson. This simple frame structure was on the National Register as an intrinsic part of the complex, and was well documented in photographs and field notes. (See Photos 21-23) Its ornamental woodwork and brackets made it a charming companion piece to the main station. Because of its important architectural relationship to the main station, it is recommended that the Shelter be reconstructed as part of the restoration of the site.

Photo 21: Outbound shelter from southwest, c. 1985

Photo 22: Outbound shelter from southeast, c. 1985

Photo 23: Outbound shelter from northwest, c. 1985.
