RR 1105-
Survey # 9-2

NEW JERSEY TRANSIT RAILROAD STATION SURVEY

✓ A. Name: Common Hopewell ^{5 + 0} Line: Reading
Historic (Delaware & Bound Brook)

FACILITY NAME: Hopewell

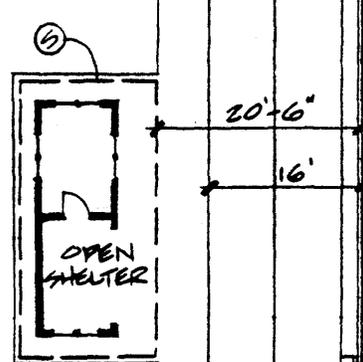
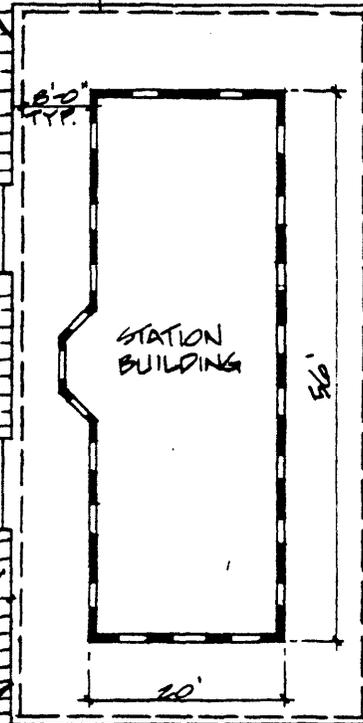
RE 1105-9200

ON GRADE CROSSING

ASPHALT PLATFORM WITH CONC. CURB

ABANDONED TRACK BED

LOADING RAMP

WALL AT CONC. PLATFORM WITH EMBANKMENT

IRON RAIL ALONG EDGE

ASPHALT PLATFORM

UNUSED TRACK
