Johnson Ferry House, Route 29

Historic Site Survey Report

Hopewell Township

Mercer County, New Jersey

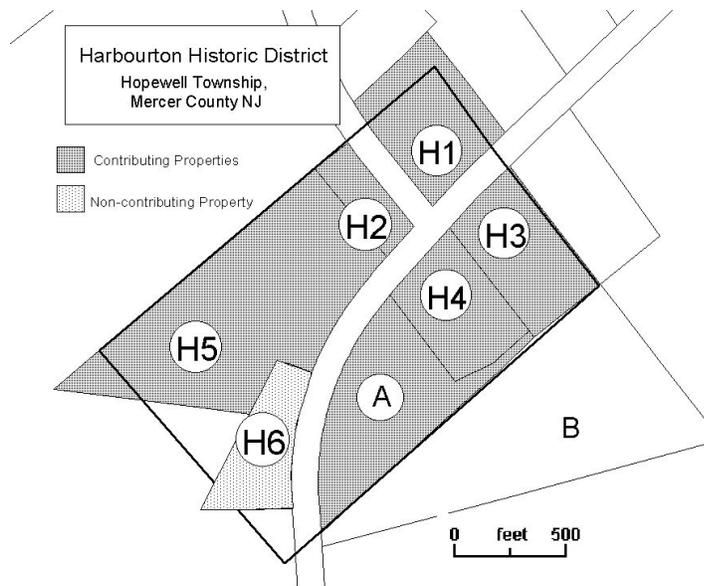
1. Harbourton Historic District. Harbourton stands as an example of a late eighteenth and early nineteenth-century village, with a cluster of buildings at an intersection serving as a commercial and social center for the surrounding family farms. Harbourton is located at the juncture of Harbourton-Rocktown Road and Harbourton-Mt. Airy Road and contains five historic properties. Harbourton-Rocktown Road was an important early route running north from Trenton to Flemington, constructed before Route 29. The Harbourton Historic District is significant for its role in local community development, architecture, agriculture, and commerce. The core of the Village Store (resource H1) was constructed in 1768 as the residence of John Harbour, the first school teacher; it later became a store and served as the village post office for many years. Later buildings included a tavern (H2) and two residences (H3, H5). An early schoolhouse was constructed on the knoll overlooking the intersection; it became a Baptist Church in 1802 (H4, rebuilt in 1879). The Harbourton School House (H6) is classified as a non-contributing resource. In the National Register nomination (listed 1974), the historic district boundary was drawn as an arbitrary rectangle around the five contributing properties. This rectangle roughly followed property lines (Figure 3).

Recommendations: The Harbourton Historic District is still eligible for the National Register. The consultant recommends extending the boundaries of the historic district (see 1a below) to incorporate nearby historic resources and historic open space, as this open space helps maintain the distinction between developed land to the north and east and the village proper (the historic characteristic and associated historic landscape). All contributing resources in the district continue to contribute to the historic significance of the district. The consultant further recommends re-classifying the sole non-contributing resource (the Harbourton School House, H6) as contributing.

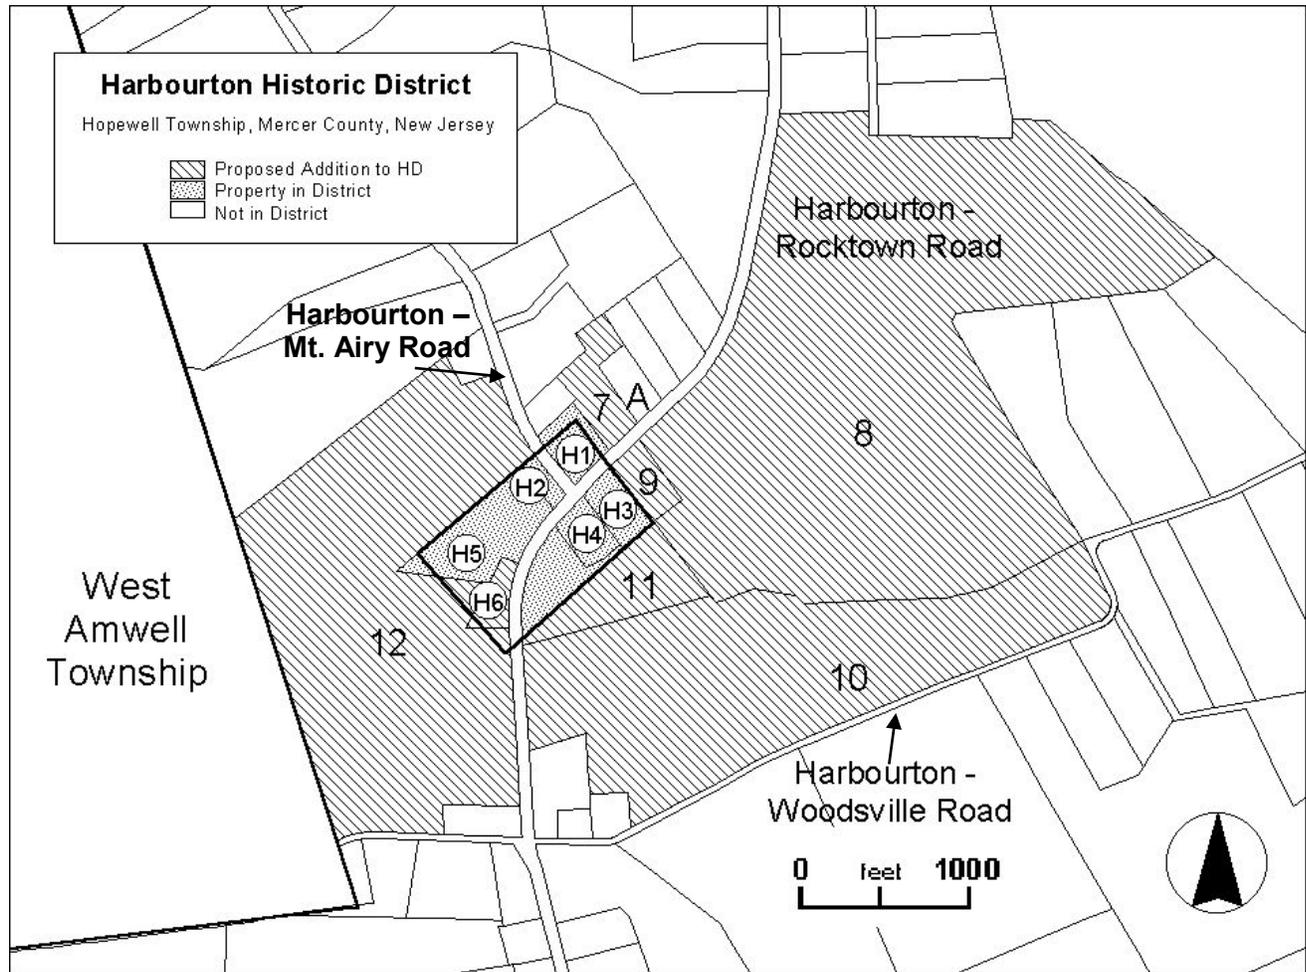
Figure 4. Proposed alterations to the Harbourton Historic District. Numbers in circles indicate historic properties in the current district (including H6, which is proposed to be re-classified as a contributing resource). Numbers 7 through 12 indicate parcels proposed to be added to the district.

Two properties with historic resources are recommended for addition to the historic district. Both of these properties contribute to the village nature of Harbourton. [See section 1c for a description of the two properties proposed for addition which contain historic resources.] The Baptist Parsonage, or the Roscoe / Rose / Lawrence House, is located on Block 28, Lot 17 (indicated as 7 on Figure 4). This house contributes to the period of significance, setback, and scale of the district and is located on the eastern border of the village settlement. The Cornell Farmstead, located southeast of the district on Block 29, Lot 13 (indicated as 8 on Figure 4), is located outside of the village proper. However, the historic landscape associated with the house (indicated as 8, 9, and 10 on Figure 4) is critical to the historic viewshed of Harbourton. The house contributes to the historic district with its setting, scale, and age.

The consultant also recommends adding two properties consisting of historic open space. One parcel southeast of the Baptist Church (indicated as 11 on Figure 4) is a part of the cemetery associated with the Harbourton Church and includes some of the more recent burials associated with the Church. The second parcel is a 60.9-acre parcel west of the district (indicated as 12 on Figure 4), stretching from Pleasant Valley – Harbourton Road to the south, west of the village to Harbourton-Mt. Airy Road on the east. Two small parts of this property are already included in the historic district boundaries. It borders on three properties already included in the district (the Harbourton Schoolhouse [H6], the Ege / Dilts / Farley Farmstead [H5], and the Hart House [H2]) and is the farmland historically associated with the Ege / Dilts / Farley Farmstead. This property frames the western reaches of the village and is critical to maintaining the historic village appearance.

1a. Historic District boundary. The consultant recommends increasing the area included in the Harbourton Historic District in order to encompass the land which contributes to the village setting (see Figure 4). Additional properties fall into two categories: those with contributing resources and historic open space. These additional parcels of land are located south, east, and west of the district. The adjoining land north of the district consists of one- to two-acre lots with modern residences which do not contribute to the historic district. A problematic property is Block 28 lot 18 (indicated as “A” on Figure 4), the location of the Harbourton creamery. This much-altered building dates to the middle of the nineteenth century but exhibits little of its historic appearance due to multiple incompatible additions.

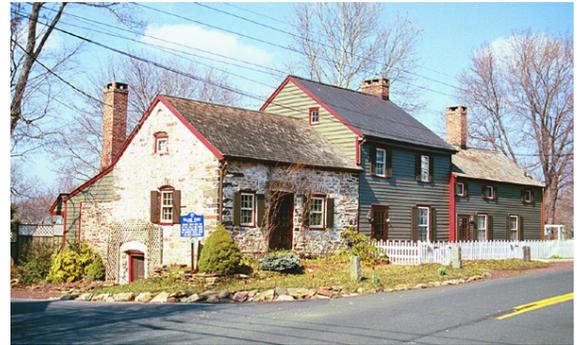
Figure 5. Harbourton Village Store (1523 Harbourton- Rocktown Road, H1, 1018282203), facing north.

The Harbourton Store is a four-part building facing south onto Harbourton – Rocktown Road. The core is a one-story, three-bay Colonial building. Two frame additions are aligned along its east end, and a stone addition was constructed on the rear (north) façade of the core. The core is an end-gabled building one story tall; it is three bays long and one bay wide. The small 6x6 windows and the doors are located under stone arches. Its main entrance is located in the center bay, although another door is located on the west end leading into the basement. A one-story, one-bay shed addition on the north side of the core has part stone and part frame walls and a standing seam tin roof. The center section of the house is a two-story, two-bay frame section with an entrance in its western bay and a large rectangular brick chimney on its east end. It is clad with a standing seam tin roof and shiplap siding. It is the highest of the four sections of the house. The east section is a two-story, three-bay section one bay deep. Its end-gabled roof is clad with wood shingles, and the walls are clad with shiplap siding. Windows are 6x6 on the first floor and six-light friezeband windows on the second floor. A multi-paneled door is located in the westernmost bay of the main (south) façade.

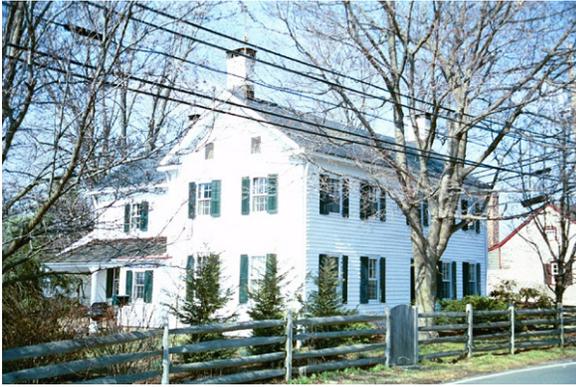
Figure 6. Hart House (1519 Harbourton-Rocktown Road, H2, -961212741), facing north.

This multi-sectional house faces south onto Harbourton-Rocktown Road. It consists of a two-story, five-bay Federal Style main block with a rear ell and a north shed addition. The core has an end-gabled roof clad with asphalt shingles and walls clad with shiplap siding. Windows are 6x6 units, and the door is located in the center bay of the main façade. The rear ell is a two-story, two-bay section with a gabled roof clad with asphalt shingles and clapboard walls. A one-story, one-bay shed-roofed section on the north end of the ell is clad with asphalt shingles and clapboard walls. A window band on the north end of the addition is the major defining feature of the section. The front yard is framed by a rail fence and is shaded by several large trees.

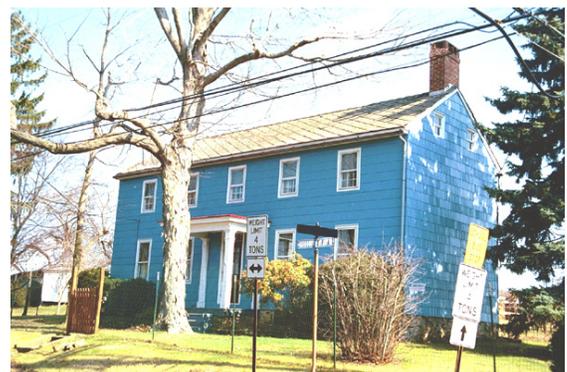
Figure 7. Cornell / Hart Farmhouse (1522 Harbourton-Rocktown Road, H3, -233306374), facing east.

The Farmhouse is located near the west border of the property, east of the Harbourton Baptist Church building. The Federal main block has a small south addition forming an awkward "T" shape. The main block is a two-story, five-bay Federal house one bay deep with an end-gabled roof facing north onto the road. It has large banded brick end chimneys and a one-story portico in the center bay composed of a nearly flat roof supported on two square columns and two pilasters. The core is clad with an asphalt shingled roof and machined shingle walls. Windows are 6x6 on the second floor and 1x1 on the first. The rear addition is a one-story, three-bay section with an end gabled roof and a large banded brick end chimney with a fireback. Its roof is clad with asphalt shingles, and its walls are clad with machine shingles. Windows are a mixture of 6x6 and 1x1. The door is located on a small porch on its west façade (partially enclosed). Salient features include the large brick chimneys, the fireback, the windows, and front entrance porch.

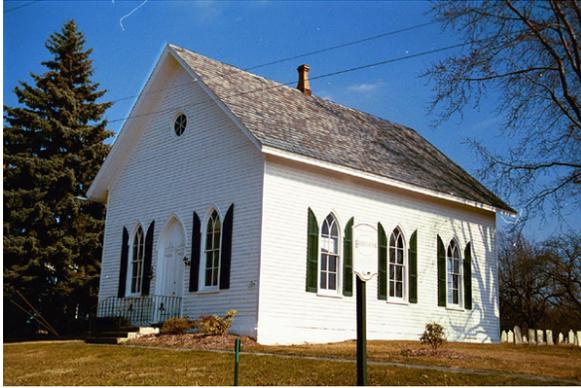
Figure 8. Harbourton Baptist Church (Harbourton-Rocktown Road, H4, 500633995), facing southeast.

The one-story, three-bay church building sits on a knoll overlooking the Harbourton intersection. The one-story, three-bay front-gabled building is three bays deep. The front-gabled roof is clad with slate shingles and features a small terra cotta chimney pot in the center of the ridge. The building is clad with clapboards. Windows are pointed arch 5x4 units with flanking pointed arch shutters. An ox-eye attic window is located on the front gable and has six lights; the south end has a small lancet window. The entrance is located in the center bay of the main façade; two narrow doors with a single molded panel are located in a recessed pointed arch bay under two molded panels in the tympanum. The foundation of the building is stuccoed. Key architectural details include its lack of ornamentation, its front-gabled orientation, its pointed arch windows with shutters, its door and surround, and its attic windows. The building has no additions. This 1879 building reflects the Chapel style of

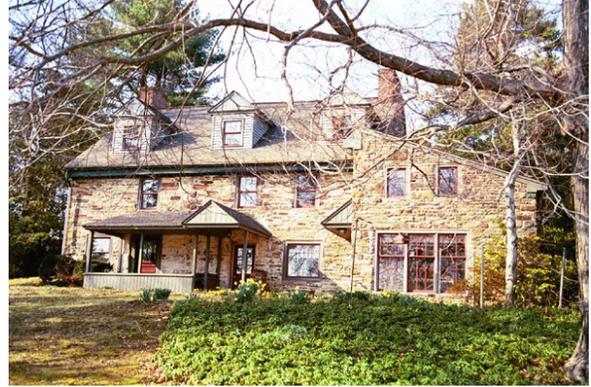
Figure 9. Ege / Dilts / Farley Farmhouse (1515 Harbourton-Rocktown Road, H5, 1020984505), west elevation.

The Ege farmhouse is a large Colonial bank building constructed c. 1765 and facing west. The house is composed of two sections forming the main block, two stone additions forming an ell, and two frame porches. The main block is a two-and-a-half story, four-bay building with an end-gabled roof. It is clad with asphalt shingles and stone walls. The main block has a small porch on both sides. The south end addition is a two-part one-and-a-half story, two-bay section with a shed roof clad with asphalt shingles and stone walls. Windows on the section are all replacement units. Significant architectural elements of the house include the coursed rubble stone walls, the window placement and size, the stone arches over the windows, the gabled roof, and the large brick chimneys.

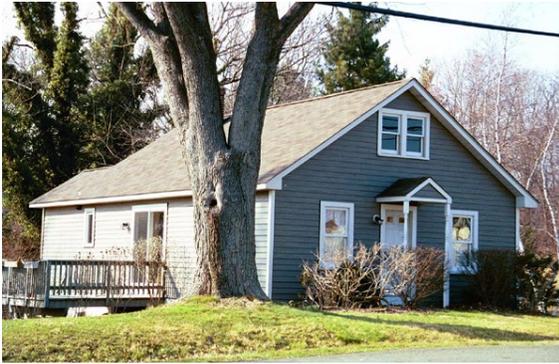
Figure 10. Harbourton School House (1513 Harbourton-Rocktown Road, H6, 1689629884), facing north.

The Harbourton Schoolhouse is a one-and-a-half story, three-bay building with a front gable facing southeast onto Harbourton-Rocktown Road. The roof is clad with asphalt shingles, and the walls are clad with vinyl siding. All windows are 1x1 replacement units, and the door on the south end has also been replaced. The building has a one-story, one-bay rear addition and a deck. It measures 20x30 with a 10x10 rear addition.

The consultant recommends that this property be re-classified as contributing to the district on the basis of its setting, setback, and architecture. Its current vinyl cladding appears to be reversible, i.e., it could be removed to expose the original material. The cladding and the rear addition have reduced the integrity of the building. The property is significant under local criteria 2 for its role in local educational trends, 4 for its architecture, and 7 for its prominent location.

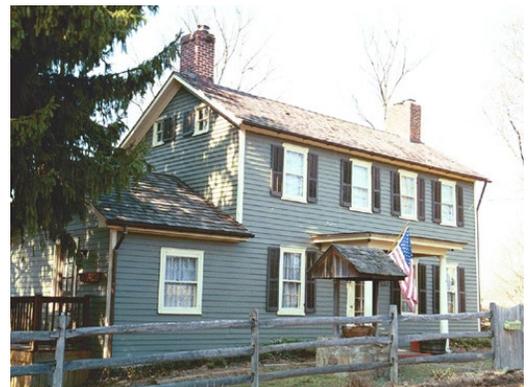
Figure 11. Roscoe / Rose / Lawrence House (1527 Harbourton-Rocktown Road, -288157826), facing north.

The Federal-style house (c. 1830) has two c. 1920 additions: one on the west end and one on the rear façade. The core is a two-story, four-bay building located about fifteen feet off Harbourton-Rocktown Road, with a split-rail fence enclosing the yard (the location of a stone well). The core has an end-gabled roof facing roughly south onto the road. The house is clad with wood shingles on the roof and shiplap siding. A one-story portico on the main (south) façade consists of a flat roof with a molded cornice supported by two unfluted columns. The door is located in the second of the four bays. The west end addition is a one-story, one-bay section one bay deep. It has an end-gabled roof and the same roof and wall cladding as the core. The rear addition is a one-story, two-bay section two bays deep. It was constructed over a full basement, giving its rear façade the appearance of being a two-story section. This addition also shares the roof and wall cladding of the core. Key features of the house are its large end chimneys, the window lintels, the Greek Revival portico, and the attic window arrangement.

The Parsonage contributes to the district in terms of proximity, setback, scale, and age. The house has a small addition on the west end and one on the north façade; these two additions are reduced in scale, historic in their own right, and do not obscure the historic appearance of the core. The house is eligible under local criteria 4 for its architecture and 7 for its prominent location on Harbourton-Rocktown Road.

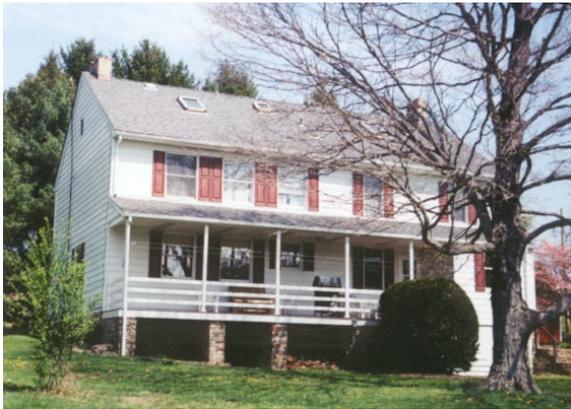
Figure 12. Cornell Farmhouse (Harbourton-Rocktown Road, -1215132305), south elevation.

The Cornell Farmhouse is a two-part building consisting of a c. 1780 core and a c. 1820 end addition forming a two-story, six-bay rectangular main block two bays deep. The house faces south and has a large full-length front porch (partially enclosed). Its end-gabled roof is clad with asphalt shingles and features a stuccoed chimney on each end. The walls are clad with aluminum siding. The doors and windows appear to be replacement units. Windows are 1x1 units, one of which is paired. The primary entrance is located on the north façade, while the historic entrance is located on the south façade.
