Johnson Ferry House, Route 29

Historic Site Survey Report

Hopewell Township

Report prepared by Wise Preservation Planning
Robert J. Wise Jr., Principal Planner
Seth B. Hinshaw, Senior Historic Preservation Planner

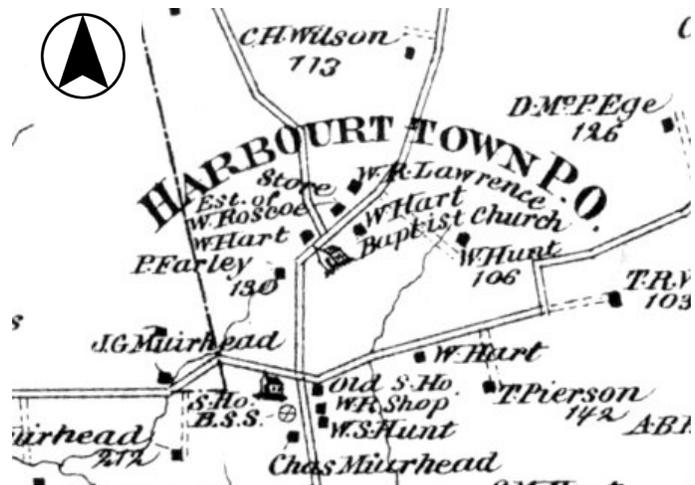
Figure 2. Detail of Everts and Stewart 1875 Map, showing Harbourton.

1. Harbourton Historic District. Harbourton stands as an example of a late eighteenth and early nineteenth-century village, with a cluster of buildings at an intersection serving as a commercial and social center for the surrounding family farms. Harbourton is located at the juncture of Harbourton-Rocktown Road and Harbourton-Mt. Airy Road and contains five historic properties. Harbourton-Rocktown Road was an important early route running north from Trenton to Flemington, constructed before Route 29. The Harbourton Historic District is significant for its role in local community development, architecture, agriculture, and commerce. The core of the Village Store (resource H1) was constructed in 1768 as the residence of John Harbour, the first school teacher; it later became a store and served as the village post office for many years. Later buildings included a tavern (H2) and two residences (H3, H5). An early schoolhouse was constructed on the knoll overlooking the intersection; it became a Baptist Church in 1802 (H4, rebuilt in 1879). The Harbourton School House (H6) is classified as a non-contributing resource. In the National Register nomination (listed 1974), the historic district boundary was drawn as an arbitrary rectangle around the five contributing properties. This rectangle roughly followed property lines (Figure 3).

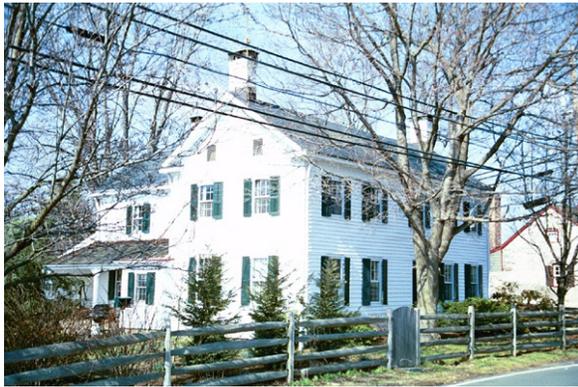
Figure 6. Hart House (1519 Harbourton-Rocktown Road, H2, -961212741), facing north.

This multi-sectional house faces south onto Harbourton-Rocktown Road. It consists of a two-story, five-bay Federal Style main block with a rear ell and a north shed addition. The core has an end-gabled roof clad with asphalt shingles and walls clad with shiplap siding. Windows are 6x6 units, and the door is located in the center bay of the main façade. The rear ell is a two-story, two-bay section with a gabled roof clad with asphalt shingles and clapboard walls. A one-story, one-bay shed-roofed section on the north end of the ell is clad with asphalt shingles and clapboard walls. A window band on the north end of the addition is the major defining feature of the section. The front yard is framed by a rail fence and is shaded by several large trees.

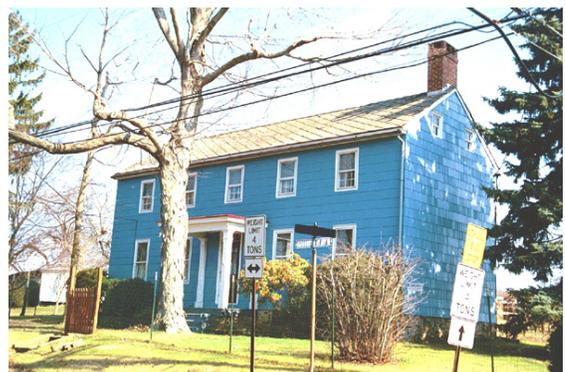
Figure 7. Cornell / Hart Farmhouse (1522 Harbourton-Rocktown Road, H3, -233306374), facing east.

The Farmhouse is located near the west border of the property, east of the Harbourton Baptist Church building. The Federal main block has a small south addition forming an awkward "T" shape. The main block is a two-story, five-bay Federal house one bay deep with an end-gabled roof facing north onto the road. It has large banded brick end chimneys and a one-story portico in the center bay composed of a nearly flat roof supported on two square columns and two pilasters. The core is clad with an asphalt shingled roof and machined shingle walls. Windows are 6x6 on the second floor and 1x1 on the first. The rear addition is a one-story, three-bay section with an end gabled roof and a large banded brick end chimney with a fireback. Its roof is clad with asphalt shingles, and its walls are clad with machine shingles. Windows are a mixture of 6x6 and 1x1. The door is located on a small porch on its west façade (partially enclosed). Salient features include the large brick chimneys, the fireback, the windows, and front entrance porch.

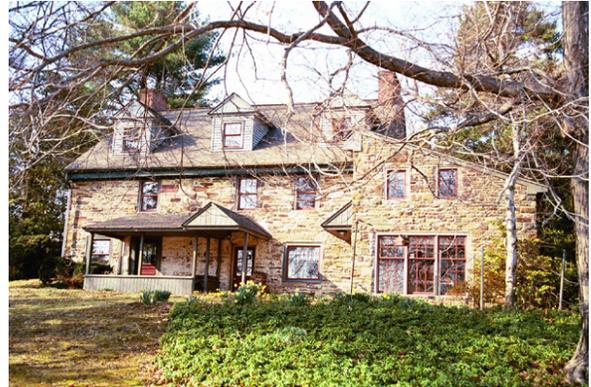
Figure 9. Ege / Dilts / Farley Farmhouse (1515 Harbourton-Rocktown Road, H5, 1020984505), west elevation.

The Ege farmhouse is a large Colonial bank building constructed c. 1765 and facing west. The house is composed of two sections forming the main block, two stone additions forming an ell, and two frame porches. The main block is a two-and-a-half story, four-bay building with an end-gabled roof. It is clad with asphalt shingles and stone walls. The main block has a small porch on both sides. The south end addition is a two-part one-and-a-half story, two-bay section with a shed roof clad with asphalt shingles and stone walls. Windows on the section are all replacement units. Significant architectural elements of the house include the coursed rubble stone walls, the window placement and size, the stone arches over the windows, the gabled roof, and the large brick chimneys.

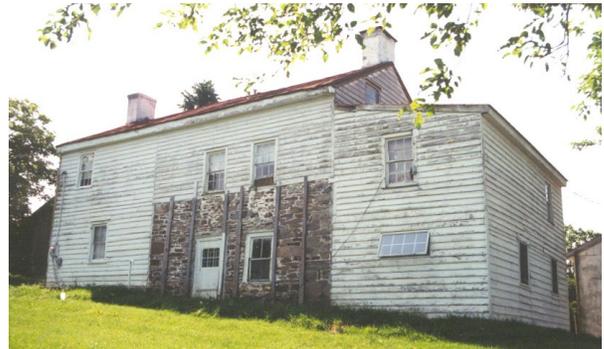
Figure 17. Atchley Farmhouse (133 Pleasant Valley Road, P1, 1024436600), north elevation.

The house is located west of the long driveway leading south from Pleasant Valley Road. It is a four-part building consisting of a three-part main block and a c. 1890 shed-roofed kitchen addition. The main block is composed of a one-story, two-bay stone Colonial-style core, a frame second floor above the core, and a c. 1840 two-story, two-bay east end addition. These sections form the two-story, four-bay main block with an end-gabled roof clad with a standing seam tin roof. The walls are clad with clapboards except for the stone core. Windows are either 6x6 or 4x4 units, and the doors are batten units. A two-story, one-bay shed-roofed kitchen addition on the west end of the main block has a roof clad with standing seam tin and clapboard walls. Windows are primarily 6x6 units, with an eight-pane hopper window on the north façade. Significant features of the house include its setting, materials, chimneys and fireback, fenestration, and the stone core section. Overall the house measures 60x20.

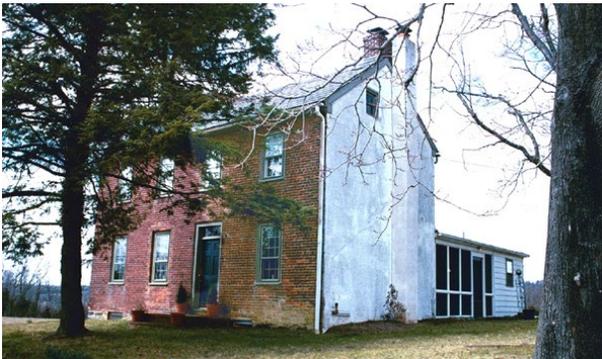
Figure 18. Brewer / Atchley Farmhouse (116 Pleasant Valley Road, P2, -831787720), facing northwest.

Brewer / Atchley Farmstead (116 Pleasant Valley Road, P2, -831787720). This 1.7-acre property, located on the northwest corner of the intersection of Barry Road and Pleasant Valley Road, is the location of a brick farmhouse and a frame wagon house. The house has been altered by the conversion of a door on the main façade into a window, but otherwise it maintains its historic appearance.

The farmhouse consists of a Federal-style core facing south onto Pleasant Valley Road, a rear addition, and an enclosed rear porch. The core is a two-story, four-bay brick section which is stuccoed on its east end. Its end-gabled roof is clad with slate. The main façade originally had doors in the second and third bays, but the door in the second bay has been reduced to a window. Windows are 6x6 on the second floor and 9x6 on the first. The rear addition is a two-story, one-bay frame section with asphalt shingles on its roof and aluminum siding on its walls. The enclosed porch wraps around three sides of the rear addition; it is a one-story section with a hipped roof clad with asphalt shingles and walls clad with aluminum siding. Significant detailing includes its brick walls, its end chimneys, its fenestration, and its door.

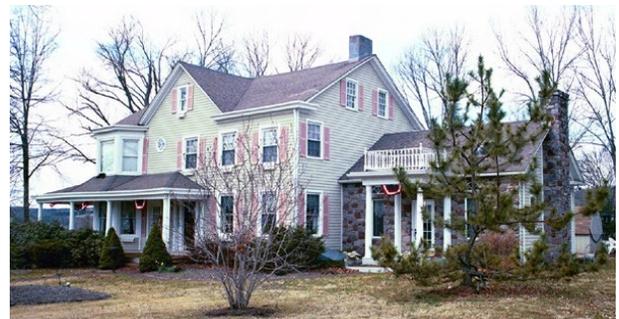
Figure 19. Hoff / Atchley Farmhouse (100 Pleasant Valley Road, P3, -1211527512), facing northwest.

This large three-part farmhouse consists of a Gothic Revival main block, an eastern addition, and a large rear addition. The main block consists of a small Penn Plan Colonial core (two-story, two-bay and two bays deep) which was enlarged into a two-and-a-half story, five-bay Gothic Revival house in the 1840s. The resulting main block faces south and has a cross gabled roof. It has asphalt shingles on its roof and vinyl-clad walls. Windows and doors on the main block have been replaced. In the 1890s the house was renovated with some Queen Anne features, including a two-story bay window on the south façade and a wrap-around porch. The one-story addition on the east end is a one-story, three-bay element with a Greek-Revival inspired portico. It has an end-gabled roof clad with asphalt shingles, a large stone end chimney, a stone south façade, and vinyl-clad east and north façades. A two-story rear addition protrudes from the northwest corner of the core. It has an end-gabled roof clad with asphalt shingles, vinyl walls, and a balcony on the west façade. Key architectural details include a bay window, wrap-around porch, and fenestration of the core.

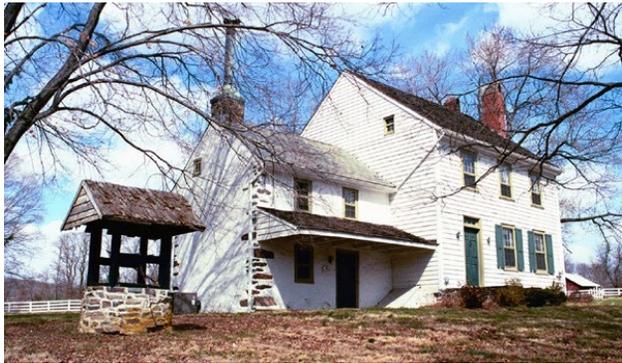
Figure 20. Major Henry Phillips Farmhouse (84 Pleasant Valley Road, P4, 216429707), facing northeast.

Major Henry Phillips (Holcomb / Ely) Farmstead (84 Pleasant Valley Road, P4, 216429707). This property, located on the north side of Pleasant Valley Road and east of the Pleasant Valley Schoolhouse, includes a farmhouse and four agricultural buildings. The primary resource is the Henry Phillips House, one of the oldest houses in the area (c. 1785). The property contributes to the district due to its integrity, setback, and agricultural use. It is individually eligible for the National Register under

Criterion A for its role in local agricultural trends, Criterion B for its association with Major Henry Phillips, who served in the American Revolution and Criterion C for its architecture. The house has a small addition dating to the Birum ownership but retains two historic sections which are highly intact on both the interior and exterior.

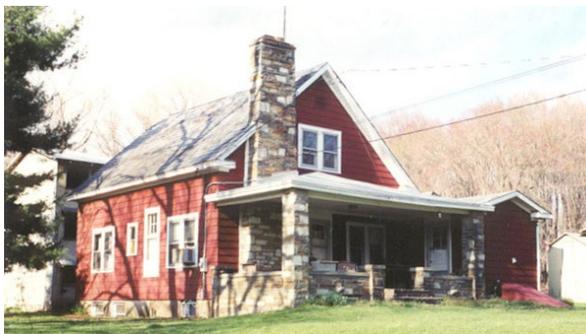
Figure 21. Pleasant Valley School House (78 Pleasant Valley Road, P5, -939563622), facing NE.

Pleasant Valley Schoolhouse (78 Pleasant Valley Road, P5, -939563622). This property is located northeast of the intersection of Pleasant Valley and Hunter Roads. Resources on the Schoolhouse property include the altered school building and three large chicken houses.

The Pleasant Valley School House is a front-gabled building facing south towards Pleasant Valley Road. The building consists of a one-and-a-half story, three-bay core four bays deep with a one-story addition on the east side, a front porch off the south façade, and a very small addition on the north end. The historic core, constructed c. 1880, is a one-room schoolhouse which was converted to a residence in the early twentieth century. The core is a one-and-a-half story, three-bay front-gabled building. Its roof is clad with slate shingles, and its walls are clad with aluminum siding. A stone chimney was added onto the main (south) façade at the time of its residential conversion. Fenestration is asymmetrical and includes many 1x1 windows of various sizes. The primary entrance is located on the south façade; a second entrance on

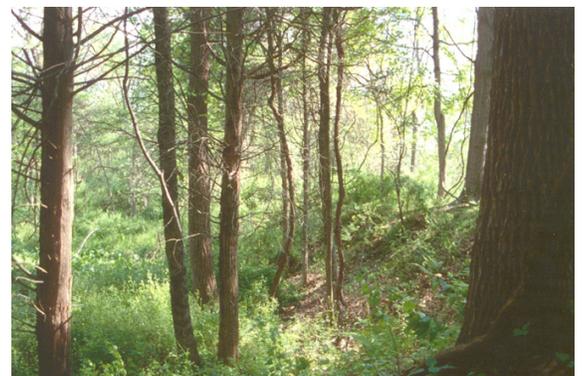
Figure 22. Raceway associated with the Phillips Mill Site (Pleasant Valley Road, P6, -1746030178).

The mill site is significant under local criteria 2 for its association with local commerce, 3 for its association with Henry Phillips, and 8 for its archaeological potential. It is one of two mill sites contributing to the Pleasant Valley Historic District.

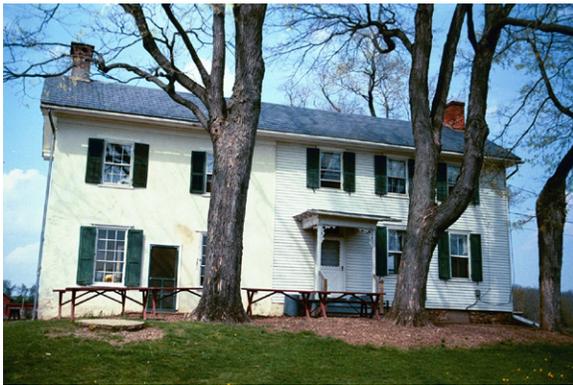
Figure 23. Howell Farmhouse (101 Hunter Road, P8, -289359418), south elevation.

The farmhouse on the Howell Farm is a three-part building facing south, with a vista overlooking the Pleasant Valley community. The farmhouse consists of a c. 1790 core with a c. 1820 east end addition and a c. 1900 rear ell. The core is a two-story, three-bay Federal-Style building two bays deep with an end-gabled roof and a centered door. It has slate shingles on its roof and stuccoed walls. Windows are 6x6 on the second floor and 9x6 on the first. The east end addition is a two-story, three-bay side-hall section. It has an end-gabled roof clad with asphalt shingles and aluminum siding on the walls. These two sections form the main block, which has a rectangular footprint and brick end chimneys. The rear ell is a two-story, one-bay section with an end chimney. Its roof is clad with asphalt shingles, and its walls are clad with aluminum siding. A one-story, one-bay enclosed room on the north end of the ell has a shed roof clad with asphalt shingles and aluminum siding on

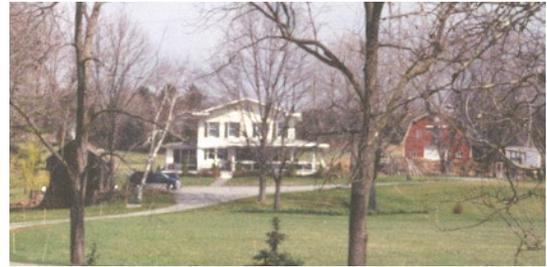
Figure 24. Smith Farmstead (48 Pleasant Valley Road, P9, 101772800), facing north.

J. Smith Farmstead (48 Pleasant Valley Road, P9, 101772800). This property stretches from Pleasant Valley Road north to Valley Road. Because the owner recently demolished the historic farmhouse and agricultural outbuildings, there are only three contributing resources on the property: the small frame garage and the bridge (P10) and mill site (P11), the latter two being the next entry. The only historic resource associated with the farmstead is a frame shed.

Status: Contributing. This property is recommended to be re-classified as non-contributing.

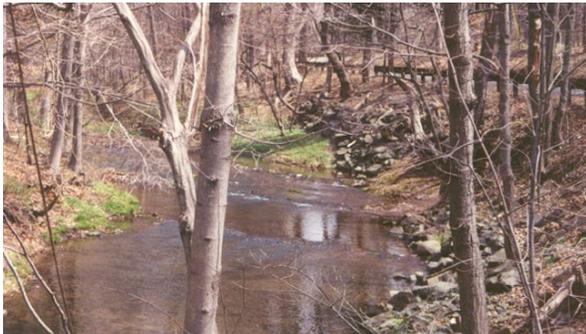
Figure 25. Smith Mill site (48 Pleasant Valley Road, P11, -227184804), facing west.

Smith Mill Site (48 Pleasant Valley Road, P11, -227184804), including the Moores Creek Bridge (P10). This mill site is located on the same property as P9 above. The mill was located west of the bridge (constructed later), but there is no physical evidence of the mill's location. The raceway was filled in sometime in the latter half of the twentieth century, but a trench-like depression running diagonally through the large front yard of the property may be a remnant of the raceway. The bridge is significant as one of the remaining iron truss bridges remaining in Hopewell Township.

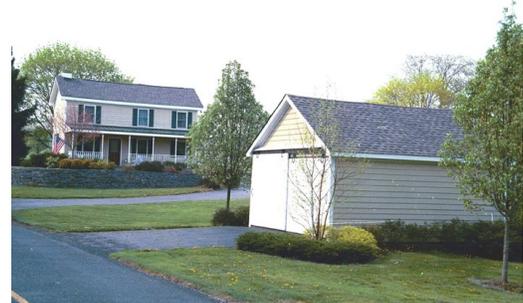
Figure 26. Phillips / Stewart / Sherman Farm (96 Valley Road, P13, 1846059058), facing north.

The house is a vernacular two-story, four-bay building one bay deep facing south. It is composed of a main block comprised of a core with a two-story east end addition and a rear ell addition. The main block has an end-gabled roof clad with asphalt shingles and walls clad with aluminum siding. The fenestration has been completely replaced, and the recent renovations included the adding of a stone fireback on the west end of the main block. The ell is a two-story, four-bay section with a highly asymmetrical fenestration. It has an

Status: Contributing. This property is recommended to be re-classified as non-contributing.

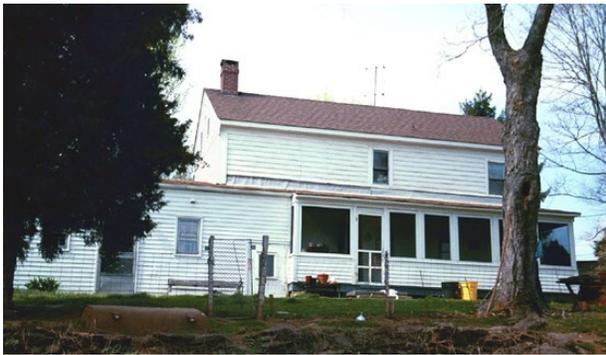
Figure 27. Smith Farmhouse (87 Valley Road, P14, 2087291016), south elevation.

Smith Farmstead (87 Valley Road, P14, 2087291016). This property is located on Valley Road west of the Phillips / Stewart / Sherman House (P13). It contains four historic resources, including a farmhouse, an eighteenth-century barn, a garage, and a workshop. The barn is the most significant resource on the property, as it illustrates eighteenth-century construction techniques of barns.

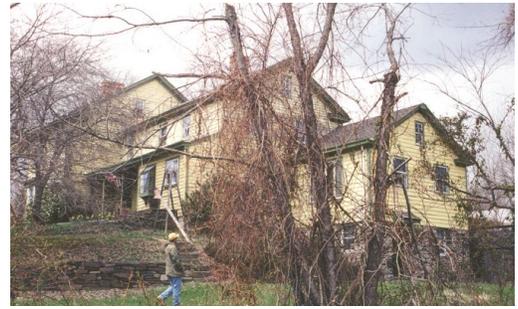
Figure 28. Lanning / Hunt Farmhouse (438 Valley Road, P15, -1896843524), facing northwest.

The Lanning / Hunt farmhouse is located about 25 feet north of Valley Road. It is a five-part building constructed on a hill, with the various sections built on different levels of ground. Four sections of the house are aligned east to west and face south onto Valley Road, with a rear ell reaching to the north. The core and east addition form the main block, which is a two-story, three-bay section between the east and west end additions. The main block has an asphalt-shingled roof and stuccoed walls. A one-story front porch on the south façade of the main block is partially enclosed. The west addition is the largest element in the house complex; it is a two-story, two-bay section with a bay window on its south façade. The west addition is accessed through a small vestibule on its west end. The east addition is a one-story, one-bay section with a full basement. It has an asphalt shingled roof and clapboard walls. The rear ell is a one-story section reaching north from the rear of the main block. Key characteristics of the house are the chimneys, the window size and placement of the core and middle section, and the cladding and cornice.

Status: Key contributing. The consultants recommend removing the property from the Pleasant Valley Historic District due to nearby non-contributing properties. The farm should be listed individually on the National Register.

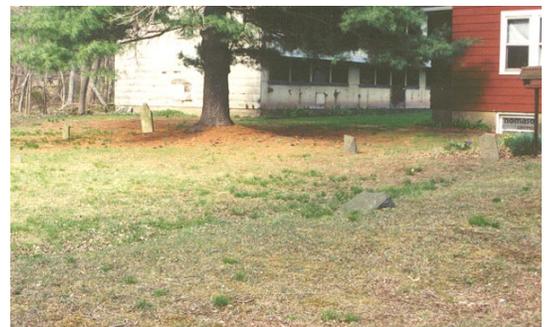
Figure 30. Phillips Burying Ground (Hunter Road, P17, 1036095445), facing northeast.

This small burial ground is located fifteen feet west of the Pleasant Valley School House and ten feet east of Hunter Road. The relatively flat ground slopes down slightly to the west towards Hunter Road, which has been recessed into the ground two feet along the property line. A large pine tree is located near the eastern edge of the burial ground and is the only vegetation except the grass. Markers are limited to seven small headstones, none readable. These markers are: three vertical rectangular slabs, two fieldstones, one shaped slab, and one square slab.

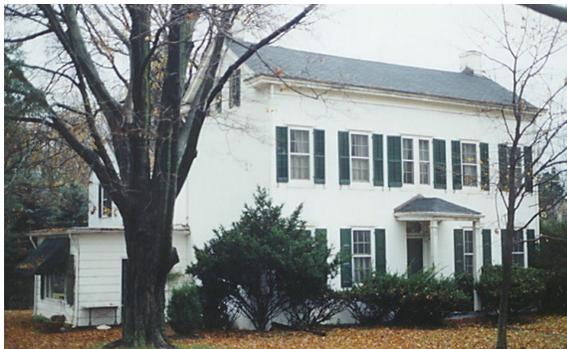
Figure 31. Hunt / Phillips Farmhouse, Pleasant Valley-Harbourton Road, 1036600865), facing NE.

Hunt / Phillips Farmhouse (Pleasant Valley – Harbourton Road, 1036600865, indicated as 18 on Figure 14). This large stuccoed house is located in the center of a 32-acre farm on the east side of Barry Road. It dates to the middle of the nineteenth century. Other historic resources on the property are a garage and a frame shed ruin.

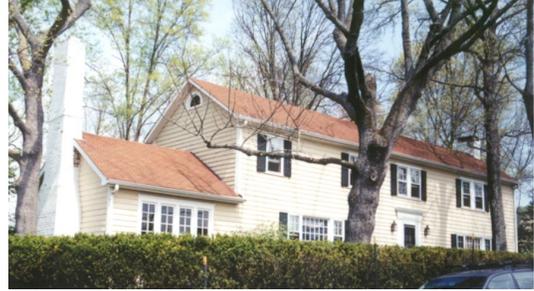
Figure 32. Smith House (120 Pleasant Valley Road, 824063455), facing NE.

Smith House (120 Pleasant Valley Road, 824063455, indicated as 19 on Figure 14). This house is located at the northeast corner of the intersection of Barry and Pleasant Valley Roads, east of the Brewer / Atchley Farmstead.

element one bay wide. Three small additions on the north façade of the house include an ell section, an enclosed porch, and an entry vestibule. Of the three, the two-story, one-bay ell is the most historic but has been highly altered.

The c. 1840 house contributes to the district in terms of its age and setting. It is also located near Pleasant Valley Road, with a setback similar to many of the resources east of the school house. The house is not eligible for individual listing on the National or State Registers due to its many alterations but does contribute to the Pleasant Valley Historic District. It is significant under local criterion 7 for its highly visible location.

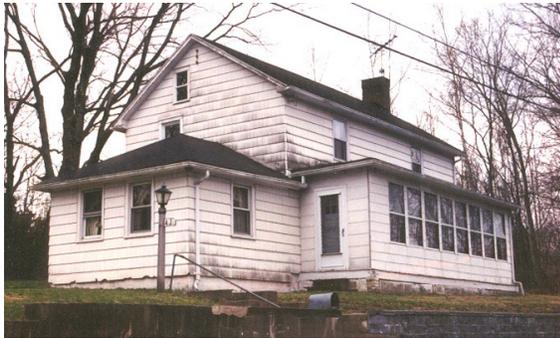
Figure 33. Hoff / Moore House (41 Pleasant Valley Road, 1447796932), facing southwest.

Hoff / Moore House (41 Pleasant Valley Road, 1447796932, indicated as 20 on Figure 14). Although not included in the Pleasant Valley Historic District in the original boundaries, the HPC asked that this property be surveyed with the Pleasant Valley resources. The half-acre lot south of Pleasant Valley Road opposite the Smith Farmstead (P9) contains a historic house and a detached garage.

The Hoff / Moore House is a five-part building facing north onto Pleasant Valley Road. It consists of a rectangular core with an enclosed porch on the north side, an eastern end addition, and two rear additions. The core is a two-story, two-bay vernacular building one bay deep. The core and all additions have an asphalt-shingled roof and walls clad with machine shingles. The enclosed porch on the north façade is a one-story section with a window band along its north façade and a door on its east end. The east end addition is a one-story, two-bay section with a hipped roof. Two small additions are located on the south façade of the building and have a shed roof. All windows on the house are 1x1 units, with those on the core and east addition being replacements.

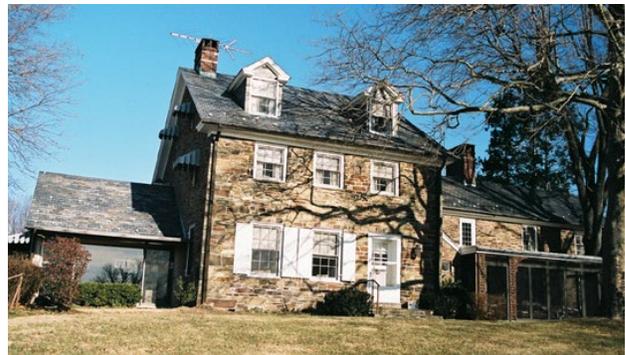
Figure 37. William Stevenson Farmhouse (P17, 188 Hunter Road), facing north.

1. Farmhouse (contributing). The four-part additive farmhouse consists of a two-and-a-half story, three-bay Colonial (3/5 Georgian) core; two two-story, two-bay east additions forming a two story, four-bay east wing; and a one-story west wing. The stone core is an example of the side-hall plan, with the door located in the east bay of the main façade. It has an end-gabled roof clad with slate shingles and facing south. A brick chimney is located on its west end. Two gabled roof dormers on the south façade have 6x6 windows and thick raking cornices. All windows and doors on the building are mid-twentieth century replacement units. The walls are semi-coursed rubble stone. Windows are 8x8 units, and first floor windows on the south façade have two-paneled shutters. The east wing is a two-story, four-bay section which is set back from the main façade of the core. It has an end-gabled roof clad with slate shingles and semi-coursed stone walls. A large brick chimney is located at the seam between the two sections, and another smaller brick chimney is located at the east end. As with the core, all windows are replacement units; they are primarily 6x6. A one-story porch on the south façade is the location of the historic entrance, although doors on the north façade are used as the primary entrance today. One of the doors on the north façade is a thick paneled door with a wide profile (although it is also a replacement unit). The west wing is a one-story, end-gabled section which is also set back from the main façade. Its roof is clad with slate, and its walls are clad with clapboards. A large window band encompasses

most of the south façade, and a smaller window band is located on the north façade. The door into the section is located on the east end.

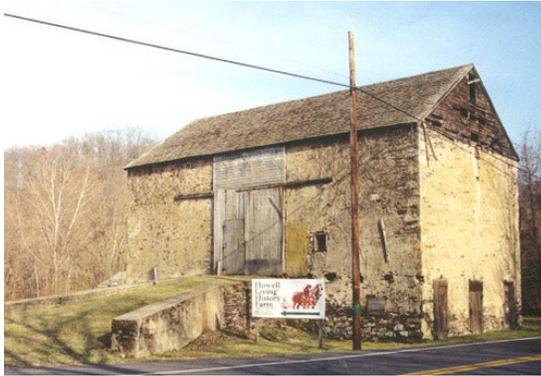
Figure 38. Upper Bellemont Barn (State Route 29, 1, -655539662), facing southeast.

Upper Bellemont Farm (State Route 29, 1, -655539662). This property is located near the northwestern corner of the Township at the intersection of Valley Road and Route 29. The farmstead lacks some integrity due to the demolition of the colonial farmhouse. However, the archaeological potential of the property is considerable, especially the ruins of the Colonial mansion house (home of the Coxe family) which are evident north of the early nineteenth-century stone barn. Other resources include three small agricultural buildings dating to the early twentieth century, a stone abutment, two building sites (foundations), and a burial ground.

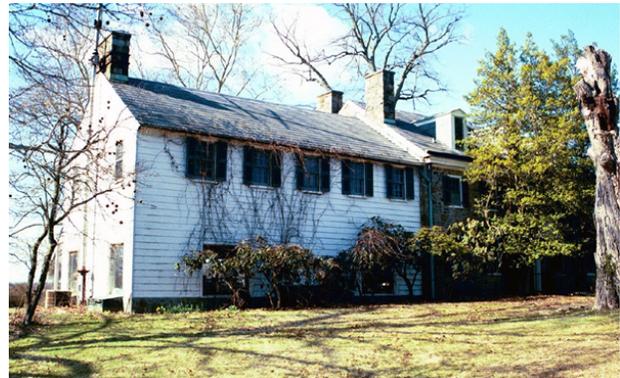
The farmhouse is located on the east end of the farmstead. It is composed of four parts, including a Colonial core dating to c. 1770, an 1819 stone addition attached to the east end of the core, a c. 1840 frame addition attached to the east end of the 1819 section, and a c. 1930 extension attached to the west end of the western addition. The core is a two-story, four-bay section two bays deep. It has an end-gabled roof with large rectangular chimneys on each end. The stone section has a one-story front porch on its north façade. The 1819 section is a larger, two-and-a-half story, five-bay addition. It has an end-gabled roof facing north and characterized by its tall gabled roof dormers. Its walls are also stone and feature a small hood over the centered door. The east addition (c. 1840) is a two-story, five-bay section two bays deep. This frame section has walls clad with aluminum siding. A one-story porch is located on its south façade. The twentieth century addition off the west end of the core is a one-story, L-shaped section. The north façade of the addition looks onto a small yard enclosed by a stone wall. All sections of the house have 6x6 windows (old if not original) and a slate roof. Key elements of the house include its large chimneys, dormers, stone walls, window size and placement, and the double door.

Figure 39. Titus / Chambers Farmhouse (29 Fiddlers Creek Road, 2, 1911996326), facing south.

Survey Recommendation: Prepare National Register nomination; eligible for local register

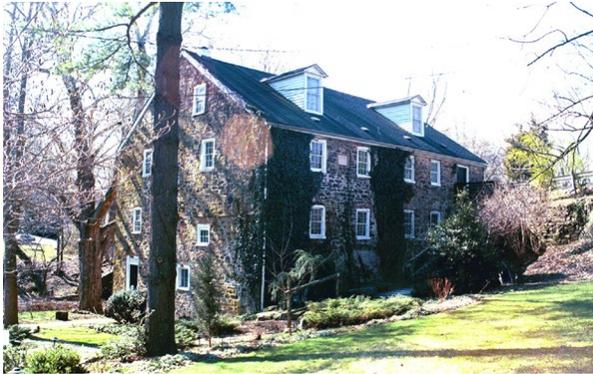
Figure 40. Somerset Roller Mill (1200 State Route 29, 3, 843615183), facing southwest.

Somerset Roller Mills (1200 Route 29, 3, 843615183). This property is located in the southwestern corner of the Township. The three historic resources are the large stone mill, dating partially to the early eighteenth century and partially to the mid-nineteenth century; a stone miller's house dating to the early nineteenth century; and a stone barn ruin. A second stone ruin has been converted into a non-contributing garage. The historic views of the mill and miller's house are highly intact, although the raceways bringing water to the mill have been altered.

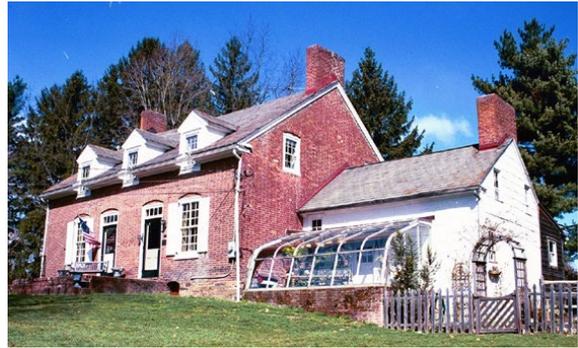
Figure 41. Jeremiah Woolsey House (237 Washington Crossing – Pennington Road, 4, 776247687), facing northwest.

The house consists of a Dutch Colonial Style core and a frame addition on the east end. The sections are aligned on an east-to-west axis and face south. The core is a one-and-a-half story, four-bay brick building with an end-gabled roof. Its roof is clad with wood shingles and features three gabled wall dormers on its south façade and a monitor dormer on its north façade. Both windows and the two front doors on the south façade are located inside slightly recessed bays with a segmental brick arches. The one-story, two-bay addition is a frame section with asphalt shingles on its roof, machined shingled walls, and a large brick chimney on its east end. A recent addition on the north façade of the addition is clad with clapboards. Significant architectural elements include its massing, Flemish bond brick walls, segmental brick arches, multi-paned windows, large brick chimneys, and doors.

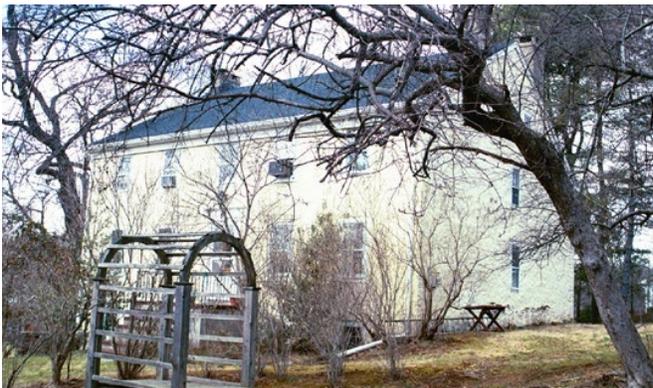
Figure 42. Poor Farm House (46 Poor Farm Road, 5, 1571655371), facing northwest.

Hopewell Township Poor Farm (46 Poor Farm Road, 5, 1571655371). The Poor Farm is located between Harbourton and Pennington in the north central portion of the Township and is the location of the Poor Farm House, a Smokehouse, and a small resource called the John Van Cleve Farmhouse.

Current NR/SR Status: Listed on the New Jersey Register 12/21/1982 and the National Register 2/16/1983
Survey Recommendation: Property is eligible for the local register

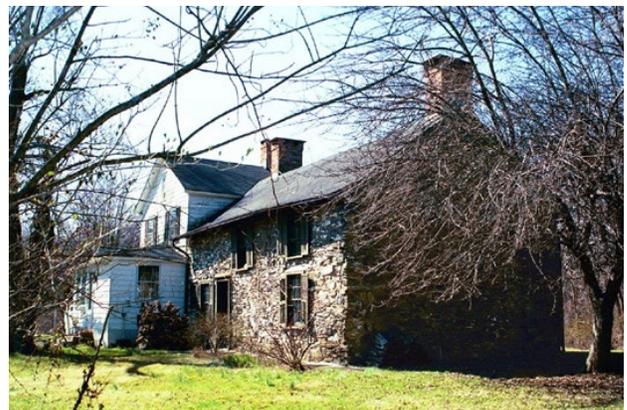
The Van Dyke / Hankins House is a Dutch Colonial-style building with three frame additions. The stone core is a two-story, five-bay building one bay wide. It has an end-gabled roof and faces south. The roof is clad with asphalt shingles and has a large banded brick chimney on each end of the ridge. The rubble stone walls were built with dark brown stone. The fenestration is asymmetrical, and the doors and windows appear old but not original. The larger, Greek-Revival addition is a two-story, two-bay section on the west end of the core. Its roof has a higher ridge than the core, and it is clad with asphalt shingles. A single chimney is located near the north end of the ridge. The walls of the addition are clad with German siding. A shed addition is located on each end of the Greek Revival section; these sections have asphalt shingles on the roof and clapboard siding. Important architectural details include the age and massing of the stone core and the frame section, window size and placement, masonry, and chimneys.

Figure 43. Jeremiah Van Dyke / Andrew B. Hankins House (91 Featherbed Lane, 6, 1636596656), facing northwest.

Survey Recommendation: Property is eligible for the local register. The National Register nomination should be completely re-written for this house.

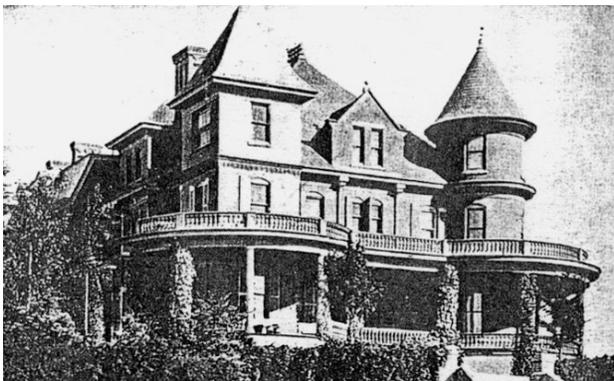
Figure 44. Edgerly's Castle (74 North Greenwood Avenue, 7, 1027357534), c. 1910, facing northeast. [Historic Photo adapted from Luce, p. 36.]

Edgerly's Castle (74 North Greenwood Avenue, 7, 1027357534). Edgerly's Castle is located immediately north of the Borough of Hopewell. The property contains a brick residence dating to the early nineteenth century which was greatly enlarged c. 1890 into a Queen Anne mansion. The owner asked that the property not be documented. The following description comes primarily from the 1984 survey and historic photographs.

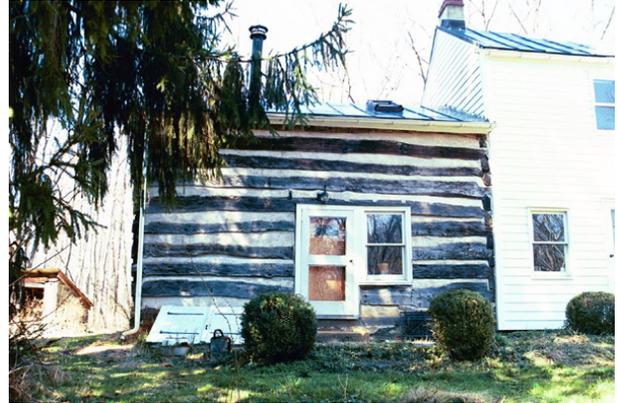
Figure 45. True / Stout House core (41 Mountain Church Road, 8, -1916354403), facing north.

The property is not listed on the New Jersey or National Registers but is eligible under Criteria B for its association with freed African Americans, C for the architecture of the house and the center addition, and D for the archaeological potential of the ruin. The house is thought to have been owned by freed African Americans (i.e., former slaves) who lived in the area prior to the Civil War, one of the few properties in the Township owned by African Americans during this time period. The house is significant as one of the few remaining log structures in the Township; however, a modern addition on the east end of the c. 1870 section has negatively impacted the integrity of the house. The property is significant under local criteria 3 for its association with freed African Americans, 4 for its architecture, and 8 for archaeology.

Survey Recommendation: Property is eligible for the New Jersey and National Registers as well as the local landmark register.

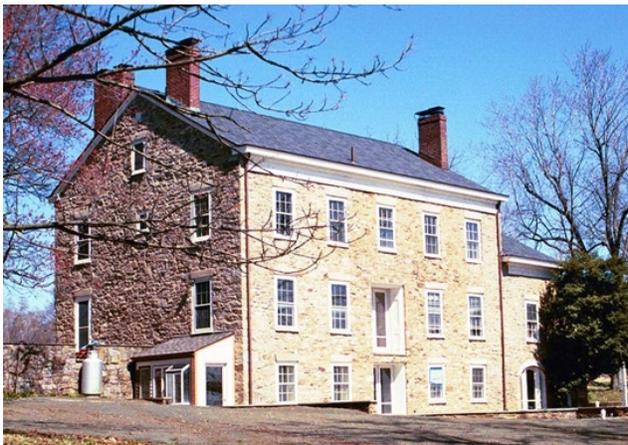
Figure 46. Joseph Stout House (Province Line Road, 9, 756845924), facing northeast.

Joseph Stout House (Province Line Road, 9, 756845924), also known as the Hunt House. This property is located near the northeast corner of the Township. The historic house and two associated buildings have been subdivided from the remainder of the farm, which includes the barn and a burial ground.

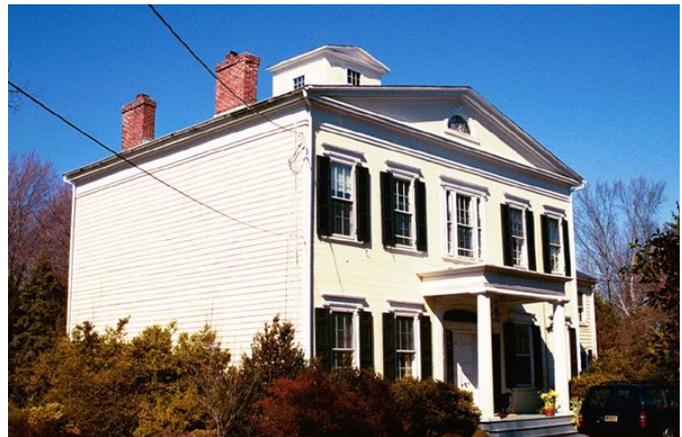
The Ichabod Leigh House consists of the c. 1835 Greek Revival core with a later frame east addition. The core is a two-story, five-bay section with a front-gabled orientation and a cupola. It has paired chimney flues on its side walls, 6x6 windows with entablatures, and a large pediment and portico on its south façade. Key architectural elements are the cupola, rectangular chimneys, main pediment with attic fanlight, windows and surrounds, flush vertical siding, and the Greek Revival portico and door.

Figure 47. Ichabod Leigh House (953 Cherry Valley Road, 10, -1110948838), facing northeast.

The property is listed on the New Jersey and National Registers and is significant under Criterion C for its architecture. The house is remarkably intact, with only one small addition on its eastern façade which has become historic in its own right. The house is significant under local criteria 4 for its architecture and 7 for its highly visible location.

Survey Recommendation: Property is eligible for the local landmark register.

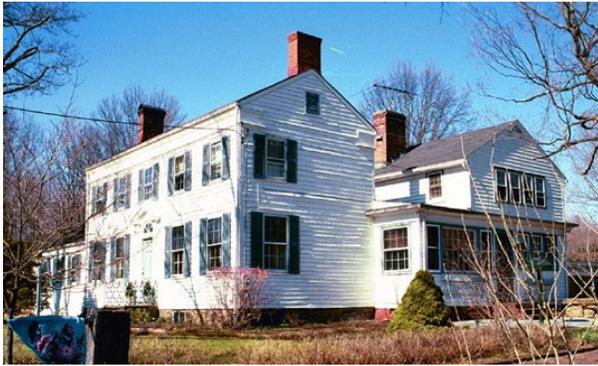
Figure 48. Griggs Farmstead (130 Cleveland Road, 11, 1957818328, facing north.

The four-part farmhouse faces southwest onto Cleveland Road. The core (the main element facing Cleveland Road) has a northern end addition, a rear addition forming a "T" shape, and a southeast addition attached to the south façade of the first rear addition. The core is a two-story, five-bay center-hall Federal Style house one bay deep. Its end-gabled roof is clad with asphalt shingles, and the walls are clad with clapboards. Windows are 6x6 with the appropriate shutters. The door in the center bay of the main façade has a fanlight and a small gabled hood. The north end addition is a one-story, three-bay section one bay deep with an end-gabled roof. It has an asphalt-shingled roof and clapboard walls. The rear addition is a two-story, five-bay section giving the house a "T" shape. Its end-gabled roof is clad with asphalt shingles, and its walls are clad with clapboards. The many

Survey Recommendation: Property is eligible for the local landmark register and should be nominated for the New Jersey and National Registers.

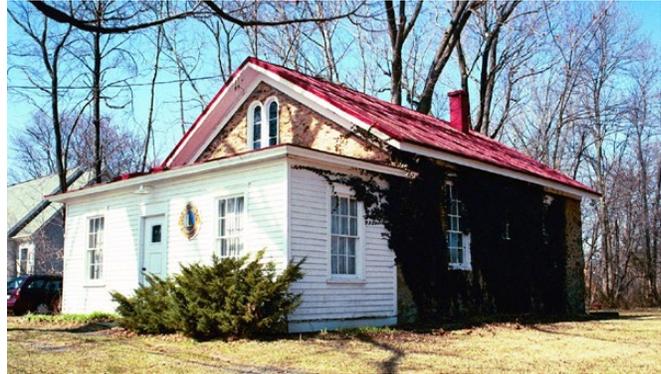
The Marshall's Corner Schoolhouse is a front-gabled vernacular building facing southeast onto Pennington-Hopewell Road. The core, constructed in 1873, is a one-story, three-bay stone building three bays deep. Its front-gabled roof is clad with standing seam tin and features a brick chimney slightly off-ridge near the north end. In the 20th-century, a one-story, three-bay addition one bay deep was constructed along the entire main façade of the core. The addition is clad with a standing seam tin roof and clapboard walls. Windows on the schoolhouse are generally 9x6 and 6x6, although the attic windows in the front gable are paired three-light units with arched heads. The entrance into the building is through a paneled door centered on the south façade of the addition. Significant details of the schoolhouse include its front-gabled orientation, its fenestration (including its arched-head attic windows), and its stone walls.

Figure 49. Marshall's Corner School House (Pennington-Hopewell Road, 12, 1017792795), facing north.

Although the building is not listed on the New Jersey or National Registers, it is significant under Criterion A for its role in the development of education in the Township and C for its architecture. The property is significant under local criteria 2 for its association with local educational trends, 4 for its architecture, and 7 for its highly visible location.

Survey Recommendation: Property is eligible for the local landmark register and should be nominated for the New Jersey and National Registers.

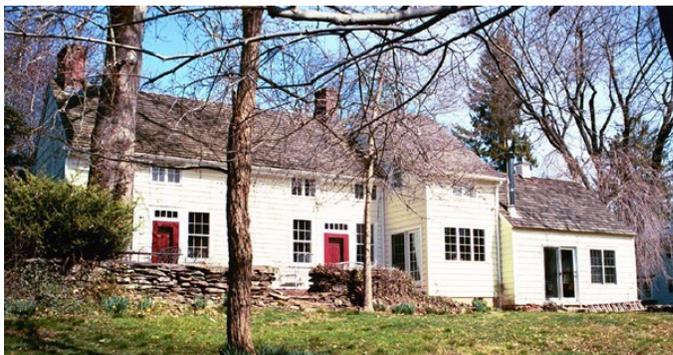
Figure 50. John Welling House (56 Curlis Avenue, 13, 831162718), south façade.

The John Welling House is a three-part residence east of Pennington and facing south. It consists of a Dutch Colonial core and two eastern end additions, each being set back slightly to the south. The core is a one-and-a-half story, six-bay house two bays deep. It has a saltbox roof clad with wood shingles and walls clad with shaped wood shingles and clapboards. A two-story, one-bay middle section has been added onto the east end of the core; it is also clad with wood shingles and clapboard walls. The one-story, two-bay east end section, on the east end of the middle section, has the same cladding as the middle section. South of the core is a large terrace formed by a large stone retaining wall curving from the core's corners. Significant architectural details include the core's

Survey Recommendation: Property is eligible for the local landmark register. In addition, an amended National Register nomination should be prepared to include additional historical information collected on the house since it was listed on the New Jersey and National Registers.

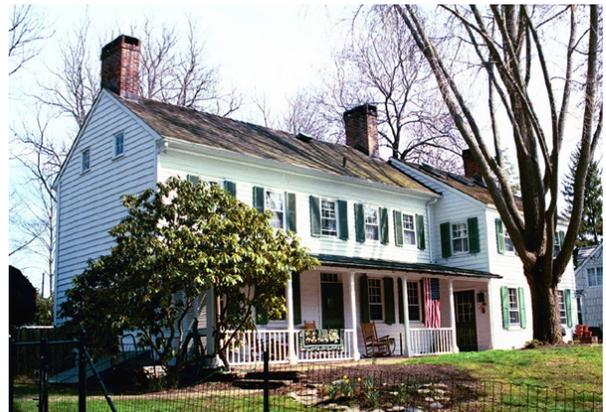
The John D. Hart House is a four-part building with a Colonial core, an east end addition, an east shed-roofed addition, and an attached garage. The core is a two-story, five-bay Georgian building two bays deep with an end-gabled roof. It faces south over a large yard. The roof is clad with wood shingles and features large rectangular chimneys on both ends. The walls are clad with clapboards and include 6x6 windows on the second floor and 9x6 on the first floor. The door is located in the center bay of the south façade. The east end addition is a two-story, two-bay section two bays deep. It has an end-gabled roof clad with wood shingles and clapboard walls. Its windows reflect those of the core. The section's only exterior door opens onto a one-story porch on the south façade of the core. A small east shed-roofed addition is a one-story, one-bay enclosed room extending along the east façade of the east addition. A garage is attached to the east addition by a breezeway; it is a one-story, two-bay section with an end-gabled roof clad with wood shingles and clapboard walls. Key architectural details include the core's massing, end chimneys, window size and placement, and doors; also, the massing and window placement of the first addition.

Figure 51. John D. Hart House (54 Curlis Avenue, 14, -1705118418), south elevation.

The John D. Hart House is listed on the New Jersey and State Registers and is significant under Criteria B for its association with the Moore family (local significance) and C for its architecture. The property is also significant under local criteria 3 for its association with the Moore family (active in the founding of Pennington and the early Township government) and 4 for its architecture.

Survey Recommendation: Property is eligible for the local landmark register. In addition, an amended National Register nomination should be prepared to include additional historical information collected on the house since it was listed on the New Jersey and National Registers.

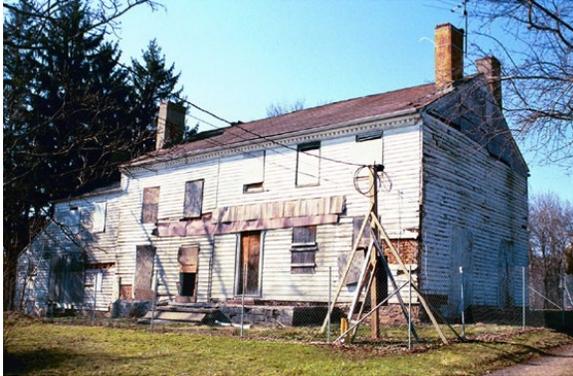
Figure 52. Hunt Farmhouse (197 Blackwell Road, 15, -301672692), south elevation.

The Hunt Farmhouse is a four-part building with a Georgian main block (core and addition) and two west end additions. The main block is a two-story, five-bay building with a center-hall interior. Its end-gabled roof faces south and is clad with asphalt shingles. The walls are clad with clapboards and cover brick nogging. The paired chimneys on each end of the main block have exposed firebacks on the east end. All windows and doors were boarded at the time of the survey. The west end addition is a two-story, two-bay section with a gabled roof clad with asphalt shingles and clapboard walls. On the west end of this addition is a smaller one-story, shed-roofed addition. The house has machined shingle siding on its south façade. It has several significant architectural details: its firebacks and chimneys, dentil cornice, brick nogging, and fenestration.

Survey Recommendation: Property is eligible for the local landmark register.

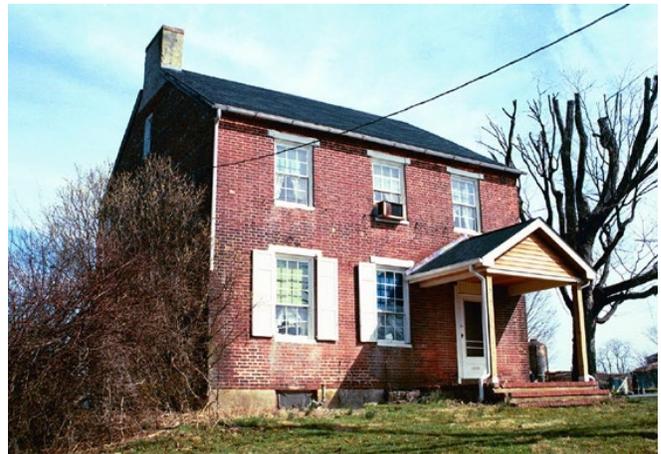
The Hart-Hoch House is a Federal-style house with a rear kitchen addition forming an ell shape and a front portico over the entrance. The core faces south towards Pennington-Washington Crossing Road. It is a two-story, three-bay building with a side-hall interior. The core has an asphalt-shingled roof and brick walls. Windows are 6x6 on the second floor and 9x6 on the first. The door is located in the east bay of the main (south) façade under the portico. The rear kitchen addition is a two-story, two-bay section aligned with the east end wall of the core. It has an asphalt-shingled roof and brick walls. Windows on the addition are primarily 6x6 units. Significant architectural details are its Flemish bond brickwork, window placement, chimneys, and the curious brick arches on the rear of the ell.

Figure 53. Hart / Hoch House (147 Pennington-Washington Crossing Road, 16, 1240574721), south elevation.

Survey Recommendation: Property is eligible for the local landmark register.

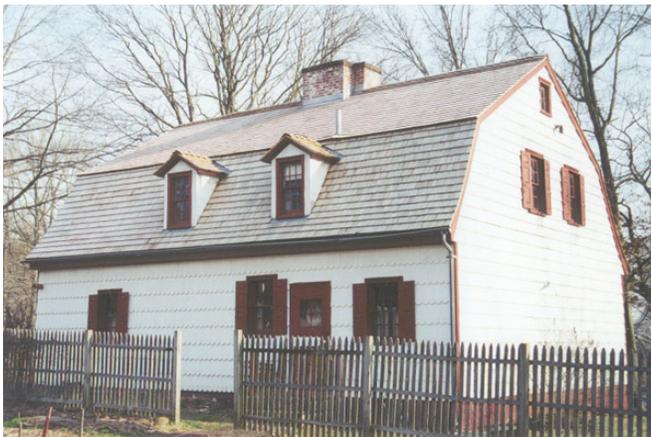
Figure 54. Johnson Ferry House (State Route 29, 17, -657334799), facing southeast.

The Johnson Ferry House is a Dutch Colonial building located in Washington's Crossing State Park. It is a large rectangular building constructed in three campaigns: the c. 1740 core (present-day kitchen), a c. 1761 addition (west of the kitchen), and a c. 1770 north addition consisting of three rooms. These three building campaigns resulted in a rectangular, gambrel-roofed one-and-a-half story building four bays long and two bays wide. The house faces south, where two doors open into the two southern rooms. Its gambrel roof has a flared lower slope (where the gabled roof dormers are located) and is clad with wood shingles. The walls are clad with shaped wood shingles on the sides and wide clapboards on the ends. [The building was re-sided in the 1930s; Figure 55 is a photocopy of a photograph showing the house prior to its restoration with the ghost of the former gabled roof of the core.] All doors and

The historic interpreter at the Ferry House has conducted some invaluable historic research into the history of the property. The house was renovated during the 1930s with the replacement of the shaped shingle siding and has been maintained with that appearance.

Survey Recommendation: Property is eligible for the local landmark register.

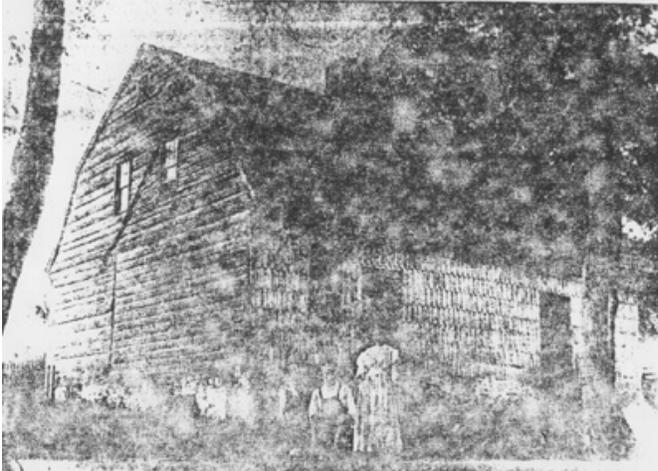
Figure 55. Historic photo of Johnson Ferry House (State Route 29, 17, -657334799), showing the former gabled roofline [courtesy of Washington Crossing State Park].

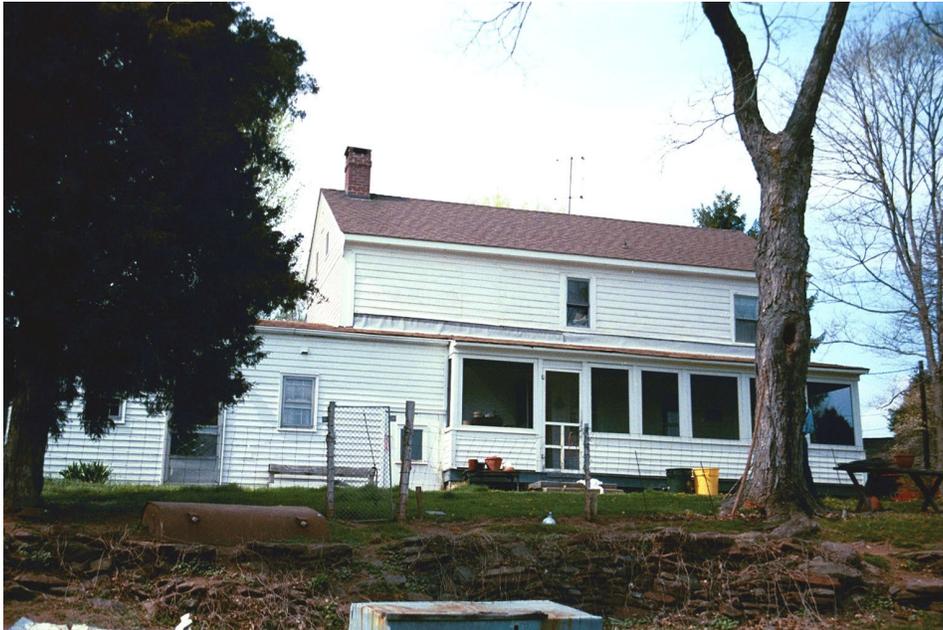
Property Photo:

Physical Condition (overall): Good

The main block is a two-story, four-bay building. It is composed of the core on the east (15 feet long and 20 feet wide) and the addition on the west (30 feet long), giving an overall measurement of 50x22. The core is about 18" wider than the addition; they are aligned on the south side and have a continuous ridge. The end-gabled roof is clad with asphalt shingles and features a banded brick chimney on the west end and a modern chimney on the north side of the core. The walls are clad with clapboards. Fenestration is irregular; some windows have been sealed, and most have been replaced. The south façade has two 1x1 windows on the second floor, one having been reduced in size. The two windows on the core (now looking out into the enclosed porch) are 6x6 units. A large one-story bay window on the east end of the core has a shed roof and overlooks the driveway. Above this bay is a 1x1 on the second floor (this window has a protruding lintel, unlike other windows and possibly altered), two four-light attic windows, and an attic louver. The north side of the house has two 1x1 windows on the second floor. All doors are located inside additions on the south, west, and north facades. The house has a stone foundation.

While the interior was not inspected, the 1983 survey form indicates that the large bay window on the core has replaced a former two-hearth corner fireplace. This would indicate that the core originally had two interior rooms on each floor.

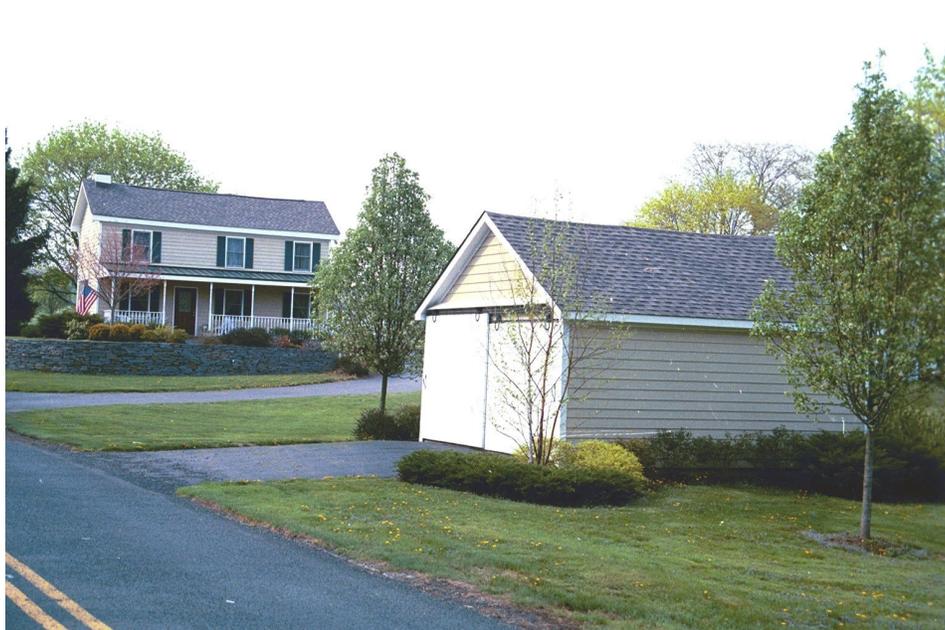
Property Photo:

The consultant recommends that this property be re-classified as a noncontributing resource in the Pleasant Valley Historic District.

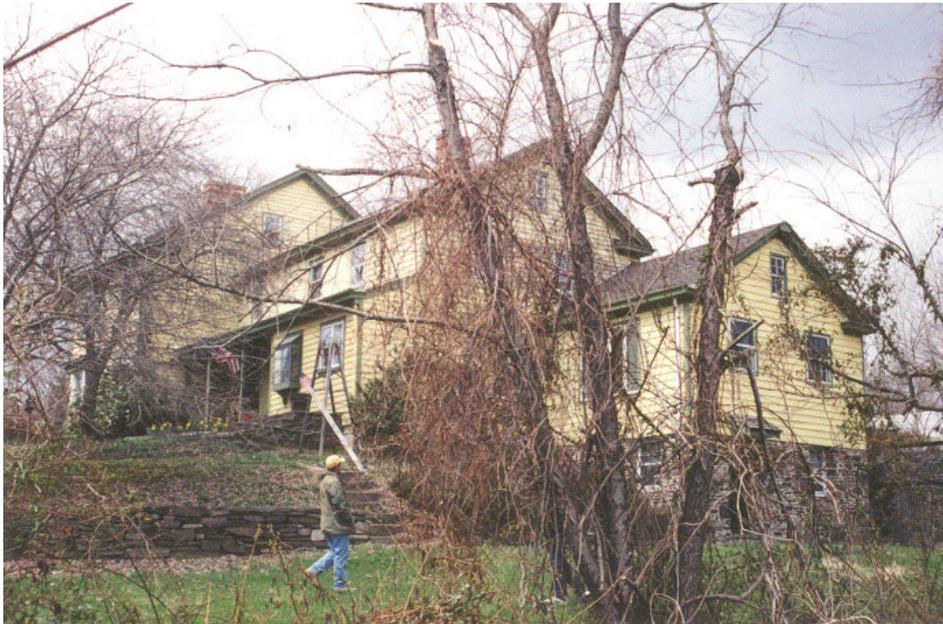
Property Photo:

Physical Condition: Good
