**HOPEWELL RAILROAD STATION
HOPEWELL, NEW JERSEY**

PRESERVATION PLAN

January 1996

Ford Farewell Mills and Gatsch, Architects
864 Mapleton Road
Princeton, New Jersey 08540
609-452-1777 fax 609-452-7192

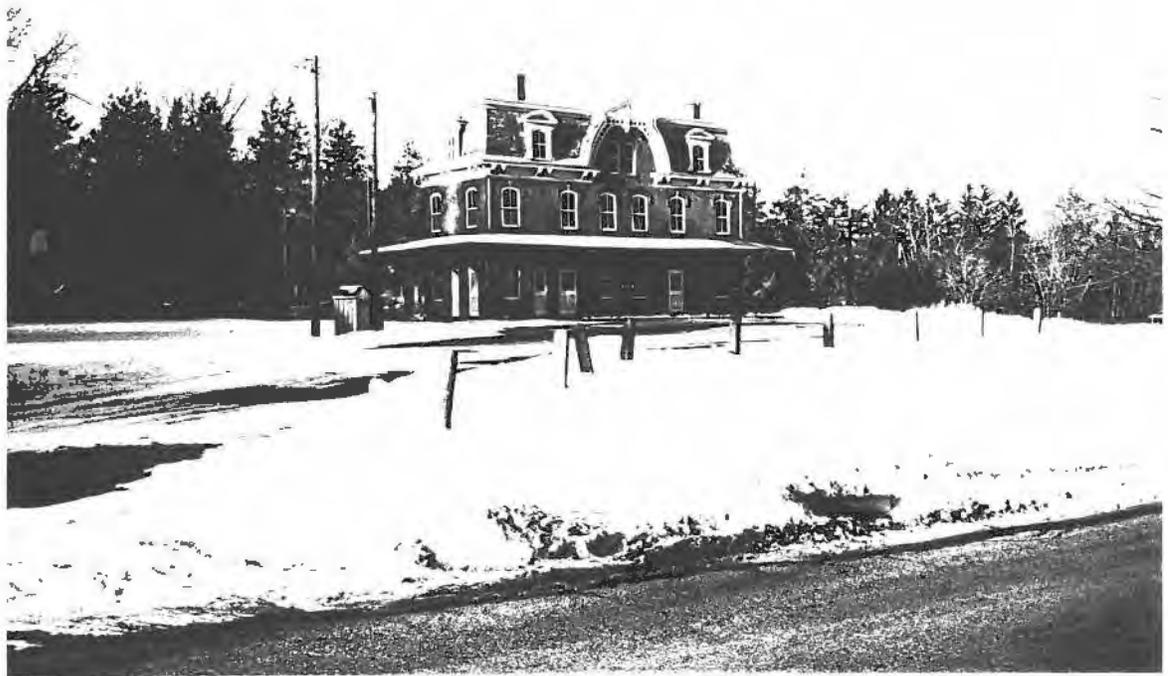
The main approach to the station, from Railroad Avenue, is by a semicircular drive. The elliptical grass plot formed by this drive is fronted by a row of mature trees. The inner perimeter of this plot is bordered by a row of hitching posts. [Photo 1] Three of these, of cut stone, probably are original. The remainder, of poured concrete, are early replacements or additions. A brick path bisects the grass plot and extends to the station. In front of the station the drive is extended into an asphalt apron that provides parking space for 40 cars. To the east of this area is a frame freight house, which, like the station, is parallel to the tracks. To the west is a treed and grassy area furnished with playground equipment. This area rises steeply to Greenwood Avenue, where the road has been elevated to cross the tracks via a bridge.

The station is set on an east-west axis, adjacent to and parallel to the inbound track. It is a rectangular, three-story building, with the third story provided by a steeply sloped mansard roof. [Photo 1]

Photo 1: View of station from Railroad Avenue, looking northeast.

The site work recommended in this Phase of the project is designed to re-establish the historic setting of the Railroad Station and to support its new use. A part of the work recommended is to repair the broad, circular drive in front of the Station (currently in poor condition), repair and/or reset the hitching posts, and relocate the basketball court and its light standards to a less conspicuous site in the "Mini-Park". Other work recommended is the restoration of the "Bishop's crook" exterior lights, re-establishment of the flower beds in their original locations, (See Figure 3) restoration of the wooden cellar bulkhead doors and railings, and the design of appropriate signage based on historic evidence.

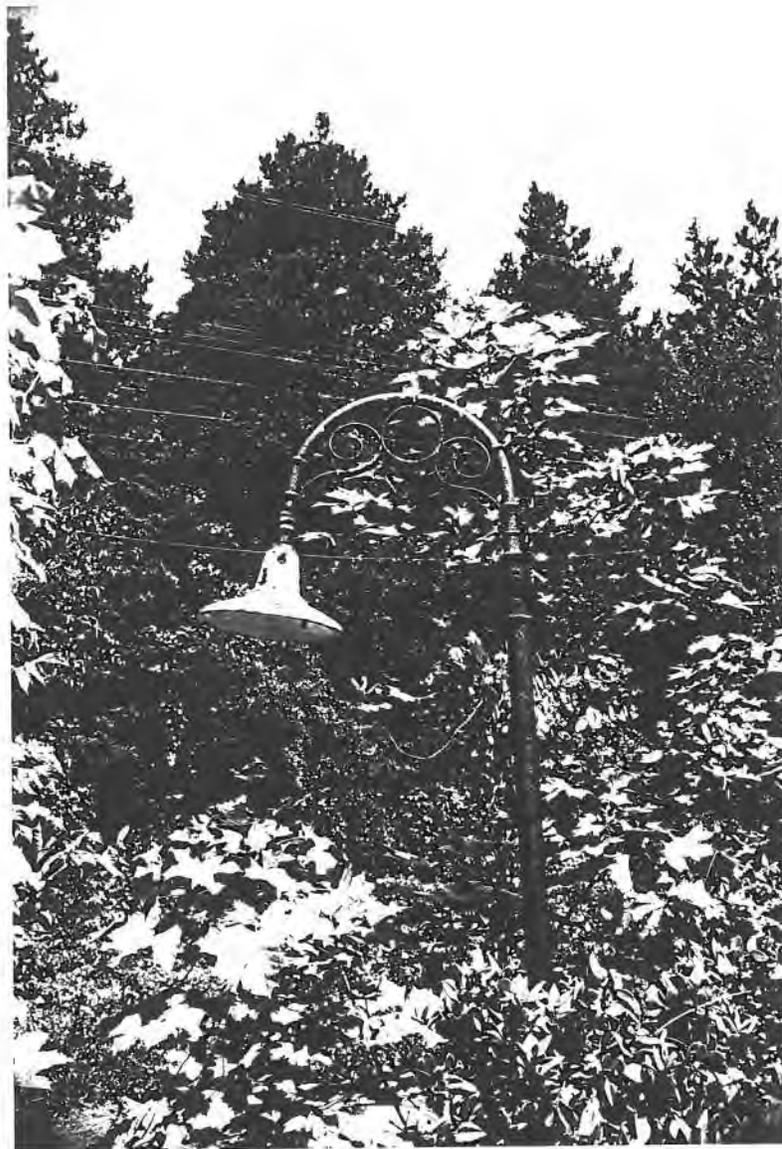
Originally artificial lighting was provided by oil or gas-fired glass lanterns, at least two suspended from the station's canopy along the north side, and probably two on the south, as well as one mounted on a pole adjacent to the steps. After the property was electrified, site lighting was provided by bishop's crook iron standards with flared enameled shades. [Photo 2]

Photo 2: Bishop's crook light fixture, c. 1985

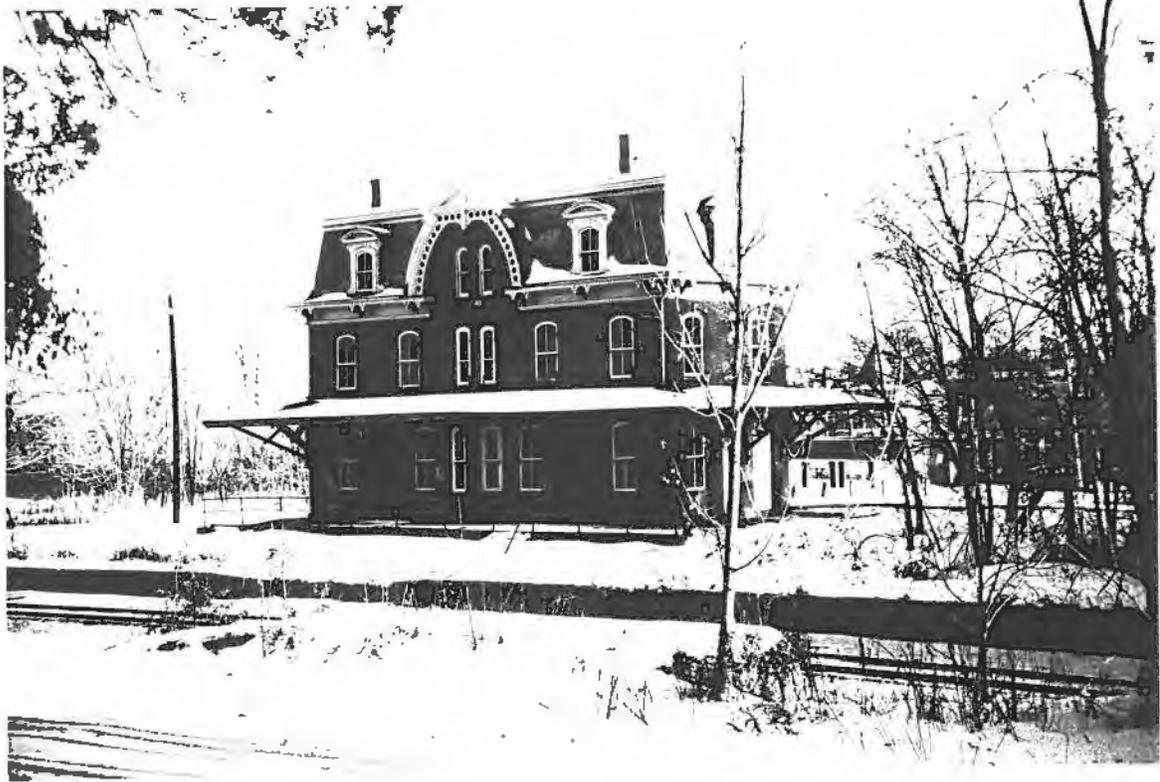
Photo 4: Station from northwest.

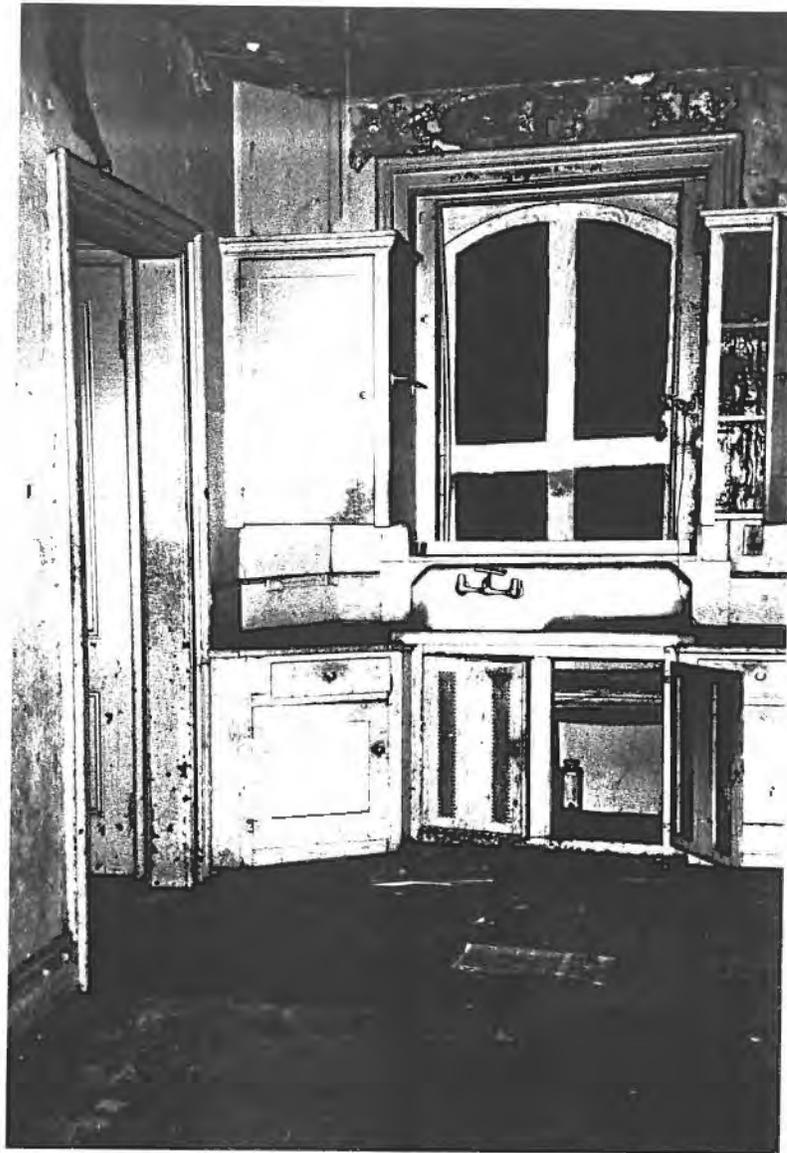
Photo 13: Kitchen equipment in Room 205.

It is anticipated that the second floor would be renovated for light office use. The west end of the building will be renovated with a new, code conforming stair which will necessitate demolition of the non-functional kitchen in Room 205 (See Photo 13). The plumbing code requires that both Men's and Women's toilet rooms be provided for this use and it is felt that they can be accommodated in the space of the former kitchen. The windows and their surrounds should remain in this area; and the doors to Room 205 and Closet 204 should be redistributed to Room 200, if possible. It is recommended that all other partitions on this floor remain intact because of the integrity of the plan. The new systems recommended for this floor are described under the Basement description.

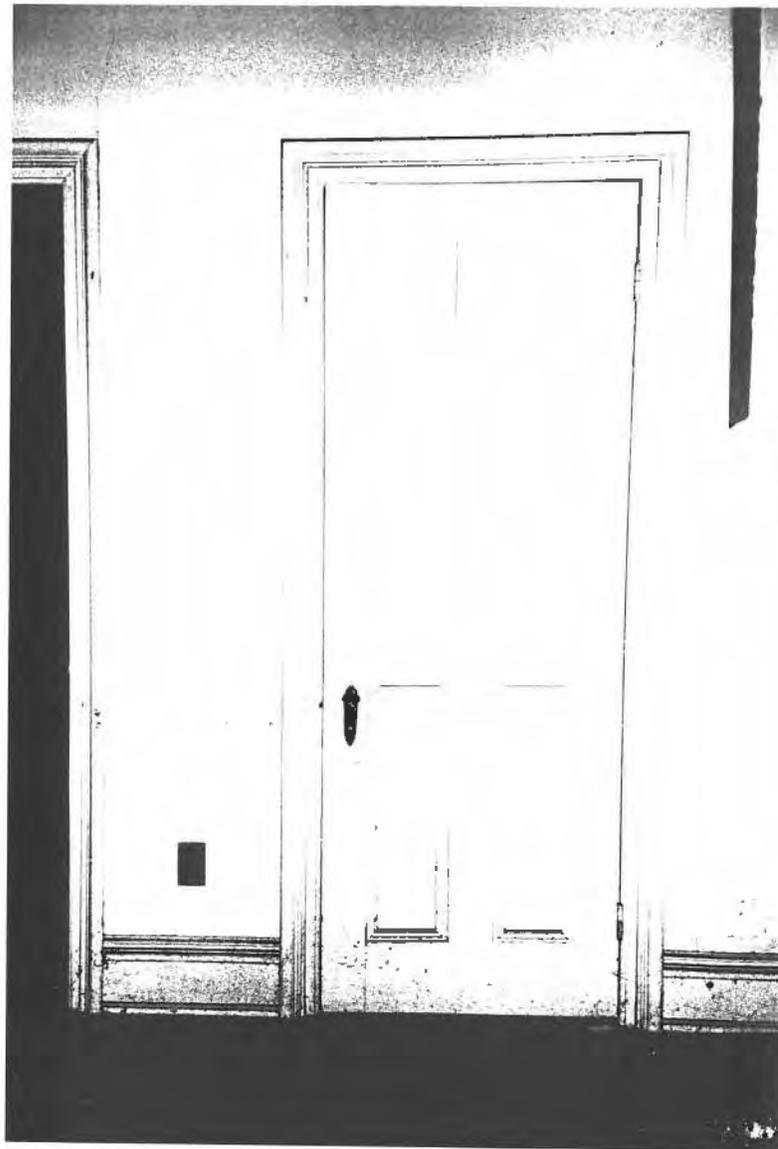
Again finishes are consistent throughout the second floor. Walls and ceilings are plaster. Floors are narrow hardwood strip. Baseboards and surrounds of all openings share a heavy molded trim. Four-paneled doors have sunk panels surrounded by moldings. [Photos 14 and 15]

Photo 14: Second floor, typical door and molding details

The windows, doors, and hardware are for the most part original and should be retained in the renovation. (Photos 14 and 15) The four panel doors have porcelain knobs and box locks which should be retained, and the typical enframements are well detailed; and related to these on the first floor, but simpler.

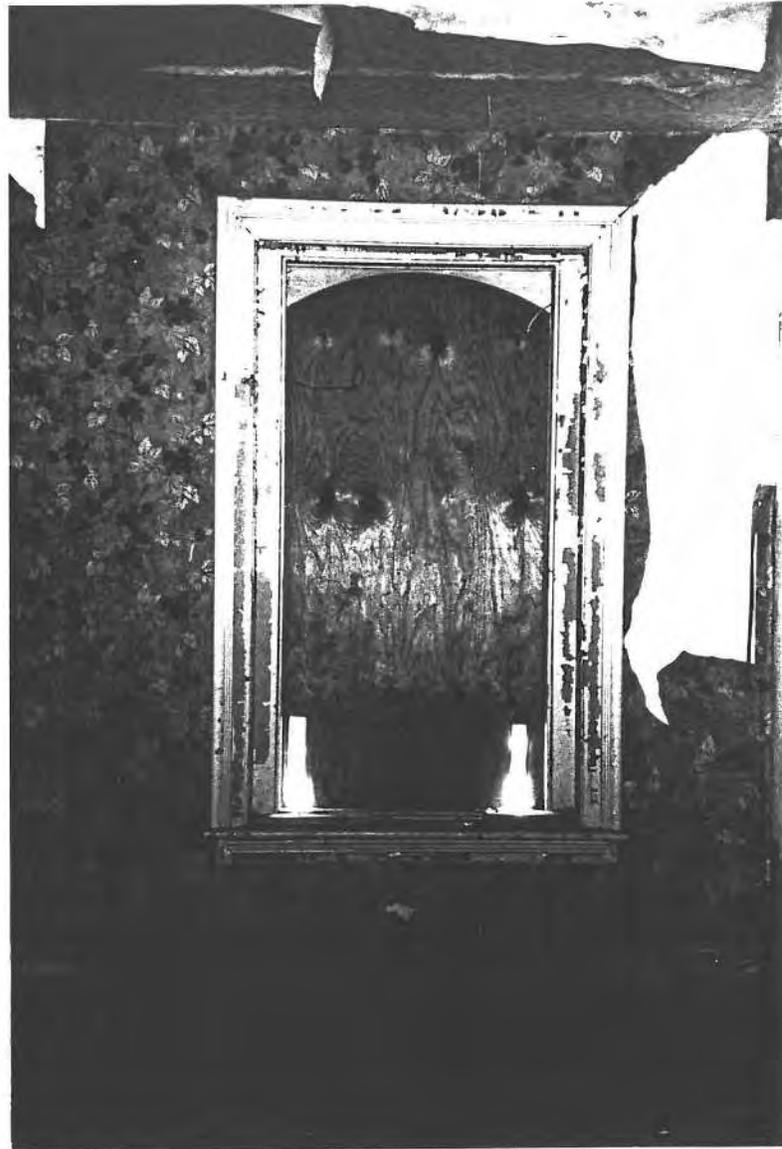
trim on the interior will need to be temporarily and carefully removed to install new sash cords to make the sash operable. The window enframements are of heavy Victorian design similar to the first floor and in excellent condition. (Photo 15)

Photo 15: Second floor, typical window details

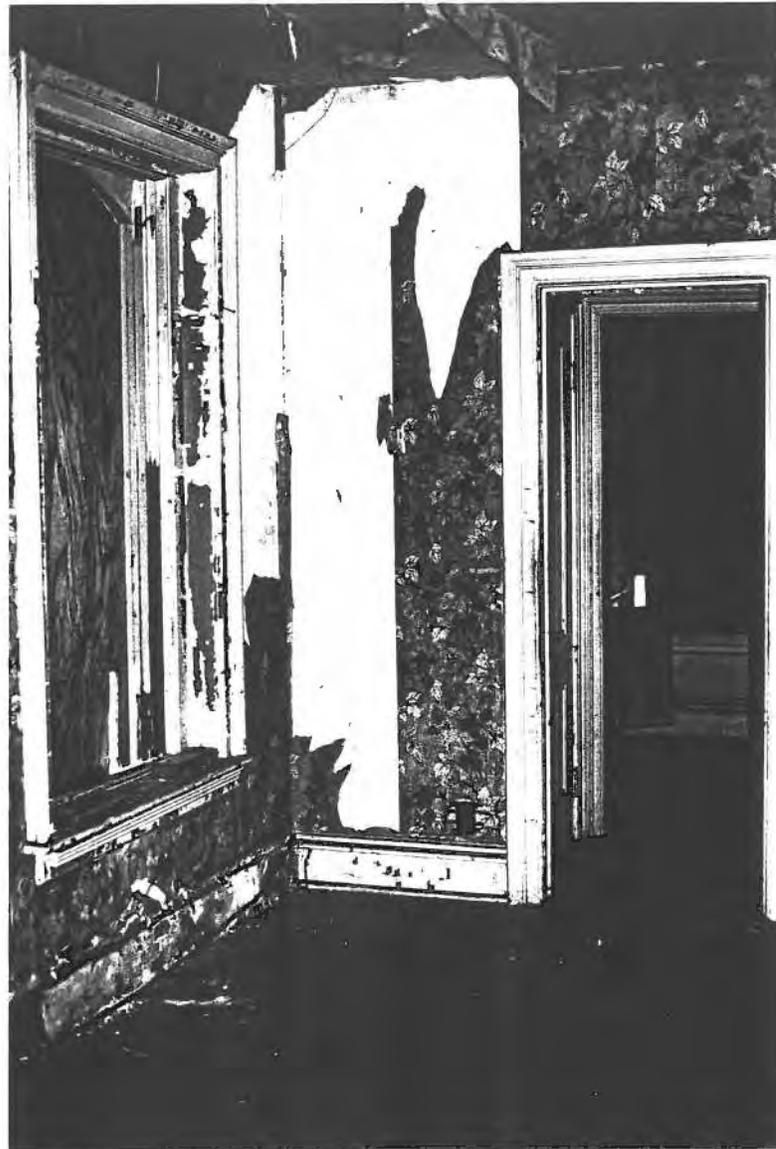
Photo 16: Southwest corner; Room 202, looking through the stair hall to Room 205.
Note original door and window enframements, baseboards and plaster.

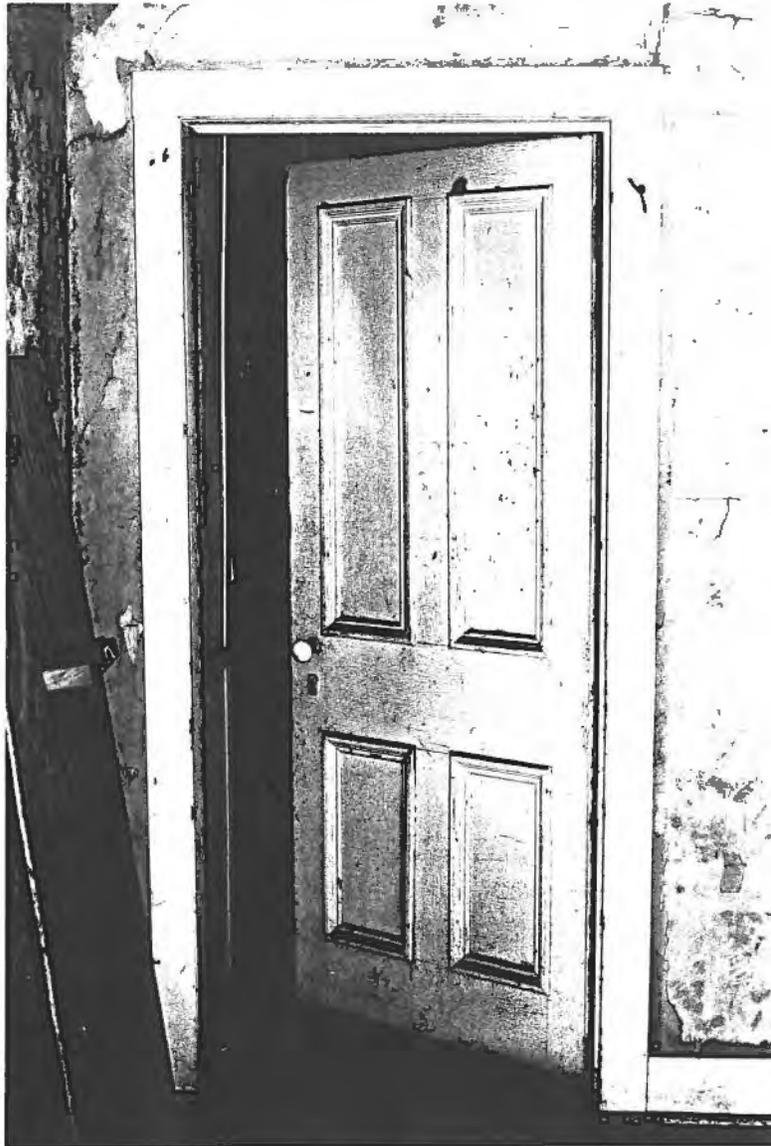
The third floor may have been an unfinished attic originally with the possible exception of Room 304, which served as the bathroom for Station Master's residence. By the design of the doors and their simple, board surrounds, (See Photos 17 and 18). Rooms 301 and 302 were probably added as bedrooms in the first quarter of this century. The paperboard walls and ceiling of Room 300 were probably added after the Second World War; to create an enclosed storage or playroom.

Photo 17: Typical third floor door, Room 302 showing simple enframements probably added in the first quarter of this century.

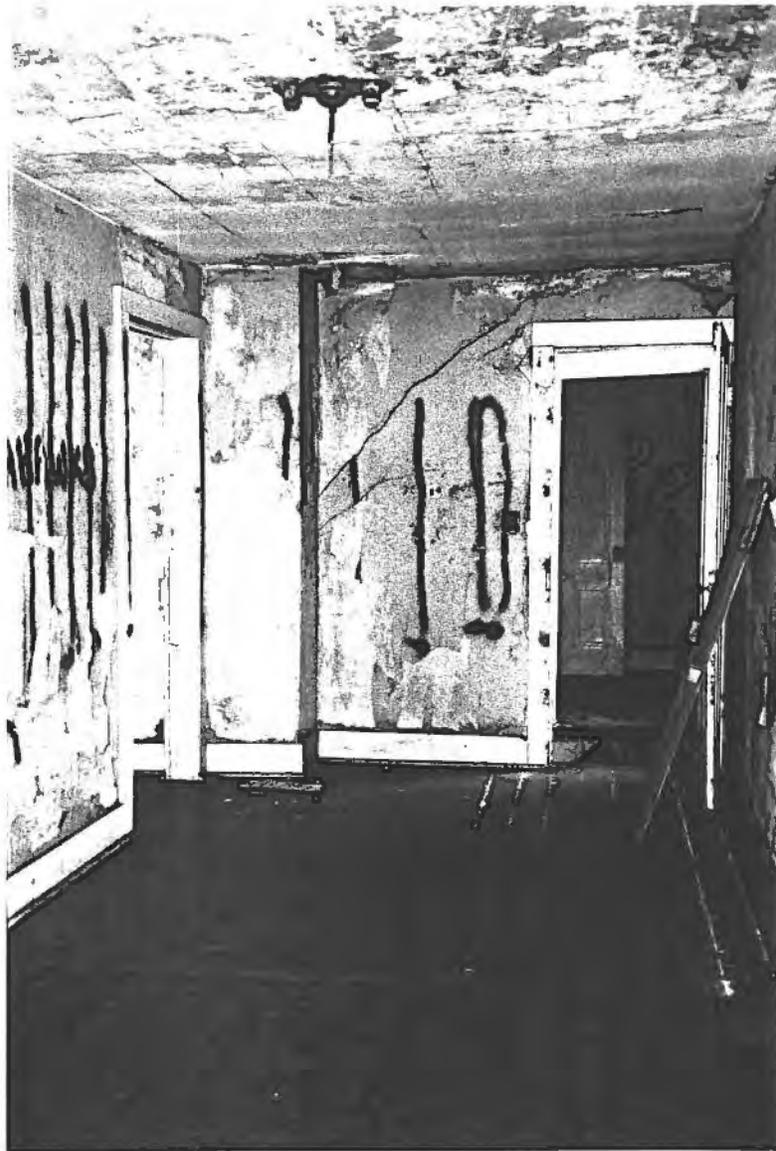
Photo 18: Third floor, showing typical finishes.
